# California Tree and Landscape Consulting, Inc.

August 30 2021

## ARBORIST REPORT & TREE INVENTORY FOR AT 680 TOWNSEND CT, FOLSOM

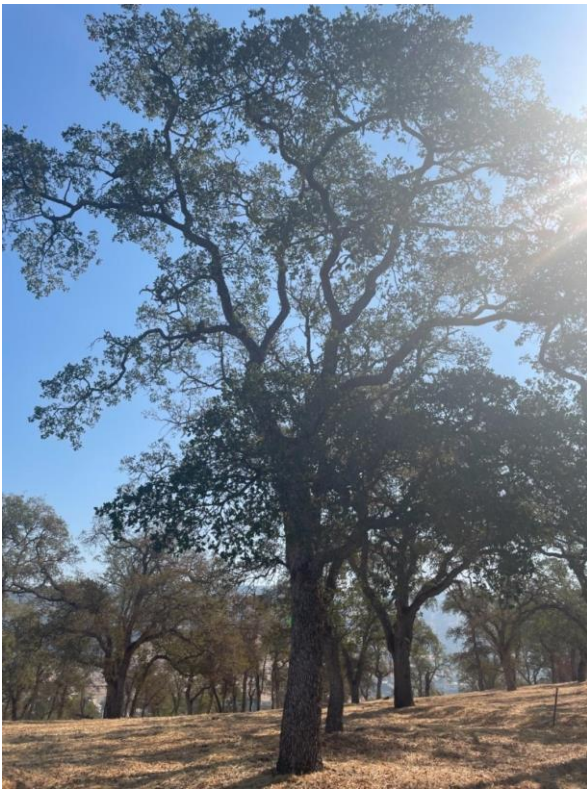
**TREE 4850**

Tree #	Common Name	Latin Name	DBH (in)	Diameter Measured at (ft)	Crown Radius (ft)	Condition	Condition Rating (%)	Observation Comments	Project Status	Inside Bldg Setback
4850	Blue Oak	Quercus douglasii	16	4.5	18	Fair	55	Flare good, branch structure good, vigor fair, low lateral to the south 20 feet from sidewalk	Retain and protect	yes
4851	Blue Oak	Quercus douglasii	8	4.5	12	Fair	45	Slightly buried root flare, small branch cavity at 6 feet,	Remove and Mitigate	Yes
4852	Blue Oak	Quercus douglasii	11	4.5	15	Poor	50	Slightly buried root flare, branch structure good, vigor poor, tip die back	Remove and Mitigate	Yes
4853	Blue Oak	Quercus douglasii	15	4.5	18	Fair	50	Slightly buried root flare, structure good, vigor fair	Retain and protect	no
4854	Blue Oak	Quercus douglasii	18	2	21	Fair	45	Buried root flare, co dom with inclusion at 5 feet above grade, branch collar cavity at 5 feet.	Remove and Mitigate	No

The trees to be retained will be fenced off to the drip line where no encroachment is approved. For large tree areas one fence can protect several trees. The proposed design of this project shows encroachment into 3 trees, 4850, 4853 and 4855. Encroachment was calculated and found to be less than 20% on any tree. These trees can be protected with tree protection fencing placed as far out to the proposed construction from the trunk as possible to protect the soil and root zone. If any work is proposed in the protected area, 4 inches of

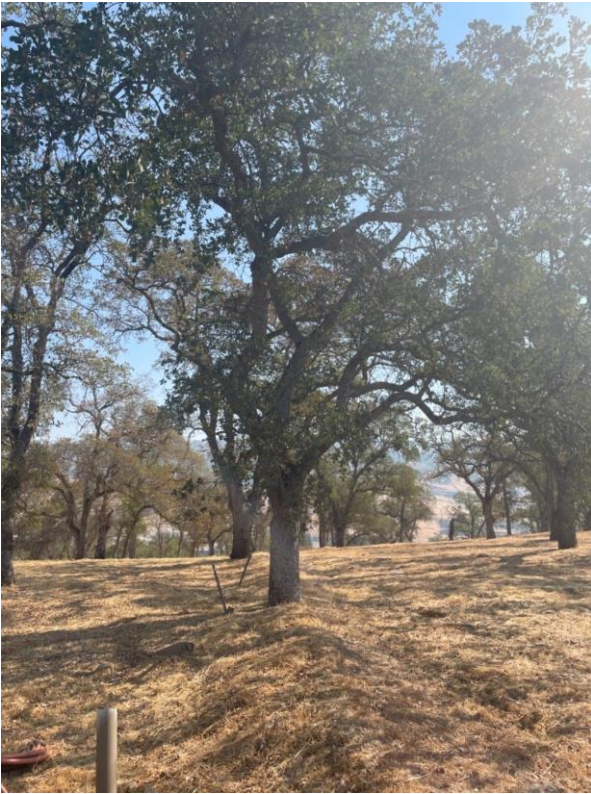
**TREE 4855**

4855	Blue Oak	Quercus douglasii	17	4.5	15	Fair	50	Root flare good, branch structure good, vigor fair, partially defoliated	Retain and protect	no
4856	Blue Oak	Quercus douglasii	14	4.5	18	Fair	50	Trunk flare good, co dominant at 8 feet, structure fair, vigor fair,	Remove and Mitigate	Yes
4857	Blue Oak	Quercus douglasii	21	4.5	18	Poor	25	Decay at base north side, tip die back, partially defoliated, low vigor, structure fair	Remove and Mitigate	Yes
4858	Blue Oak	Quercus douglasii	20	4.5	21	Fair	45	Trunk flare good, structure fair, vigor fair, co dom at 5 feet above grade,	Remove and Mitigate	Yes
4859	Blue Oak	Quercus douglasii	18	4.5	12	Dead	0	Large decay column in trunk,	Remove and Mitigate	Yes

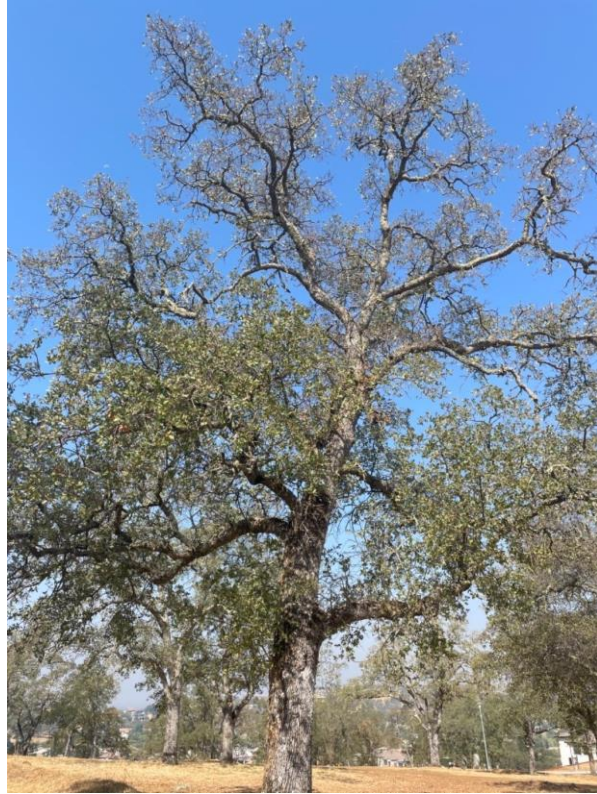
**TREE 4861**

Tree #	Common Name	Latin Name	DBH (in)	Diameter Measured at (ft)	Crown Radius (ft)	Condition	Condition Rating (%)	Observation Comments	Project Status	Inside Bldg Setback
4860	Blue Oak	Quercus douglasii	7	4.5	12	Fair	50	Single stem understory, vigor fair	Remove and Mitigate	Yes
4861	Blue Oak	Quercus douglasii	18	4.5	21	Fair	50	Trunk flare good co dom at 10 feet above grade, branch structure good, vigor fair,	Remove and Mitigate	Yes
4862	Blue Oak	Quercus douglasii	14	4.5	15	Fair	55	Trunk flare good structure good vigor fair,	Remove and Mitigate	Yes
4863	Blue Oak	Quercus douglasii	11.4	4.5	12	Fair	50	2 Stems at base 9" & 7"; Trunk flare good, structure fair, vigor fair,	Retain and protect	
4864	Blue Oak	Quercus douglasii	13	4.5	15	Fair	55	Offsite, neighboring tree, flare good, structure fair, vigor fair, 5 feet from property line extends into property 10 feet	Retain and protect	
4865	Blue Oak	Quercus douglasii	10	4.5	15	Fair	50	Offsite, neighboring tree, flare good, structure fair, vigor fair, 8 feet from property line, extends into property 7'	Retain and protect
