PRE-CONSTRUCTION ARBORIST REPORT & TREE PRESERVATION PLAN

RE: 663 Townsend, Lakeview Oaks Subdivision Lot #92, Folsom, California; APN #072-3330-010

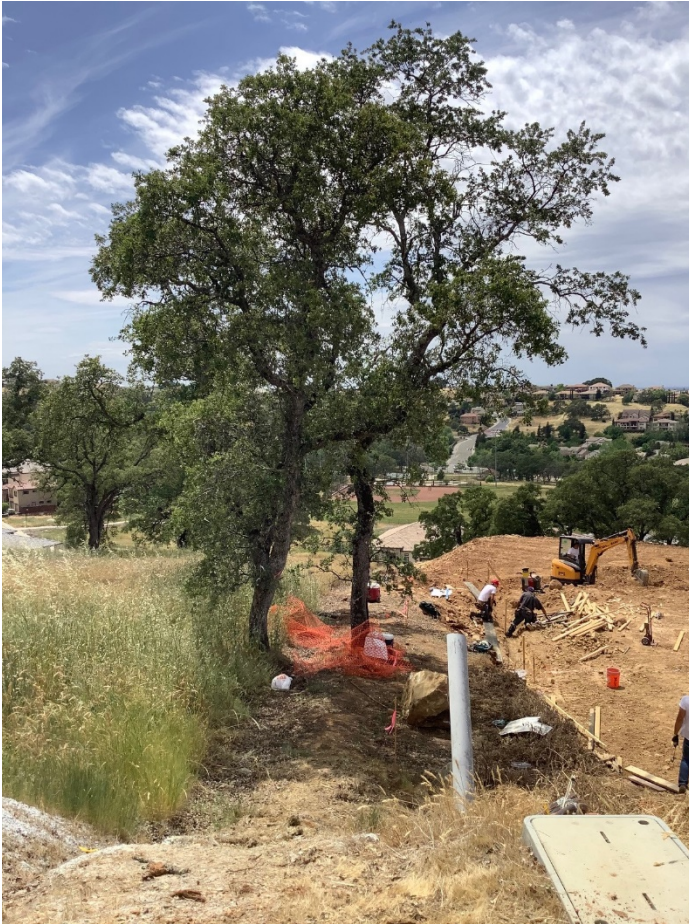
Field Tag #	Old Tag #	Offsite	Species Common Name	Species Botanical Name	DBH	Measured at	Canopy Radius	Arborist Rating	Dvlpmt Status	Notes	Preservation Actions
4509	1813		Blue oak	Quercus douglasii	11	24	18	3 Fair - Minor Problems	Proposed for Removal	No evidence of canker at ground but fill could have been applied from drainage swale at less than 1'. Narrow attachment at 5', dense twiggy growth adequate density	
4510			Blue oak	Quercus douglasii	15.5	42	29	1 Extreme Structure or Health Problems	Proposed for Removal	Too much decay below 3'. otherwise fair to poor structure, fair to good density and vigor	
4511	1812		Blue oak	Quercus douglasii	11	54	14	2 Major Structure or Health Problems	Proposed for Removal	Abnormal trunk shape with bends and crooks from suppression, epicormic growth mostly from 5' to 20', fair to poor canopy above

Photo 1, Trees 4509 (left) and 4511 (right)
Showing neighbors use of protection area

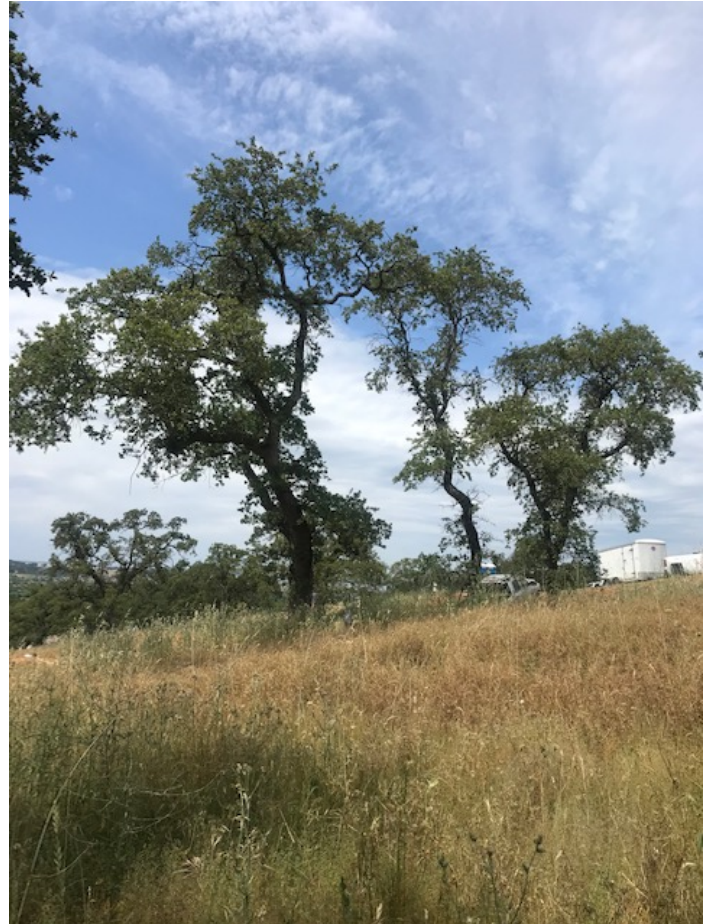
4508	2628		Blue oak	Quercus douglasii	18	54	21	2 Major Structure or Health Problems	Proposed for Removal	Some evidence of canker at ground, codominant at 6' wide, north side of tree has several bird cavities and very little foliage, southside of tree has a lean with correction, fair structure and health. Poor density at top

Photo 2, Tree 4508 (left), 4511 and 4509 (right)
