California Tree and Landscape Consulting, Inc.

August 22, 2022

RE: ARBORIST REPORT FOR HOME REMODEL AT 7635 BALDWIN DAM ROAD, FOLSOM

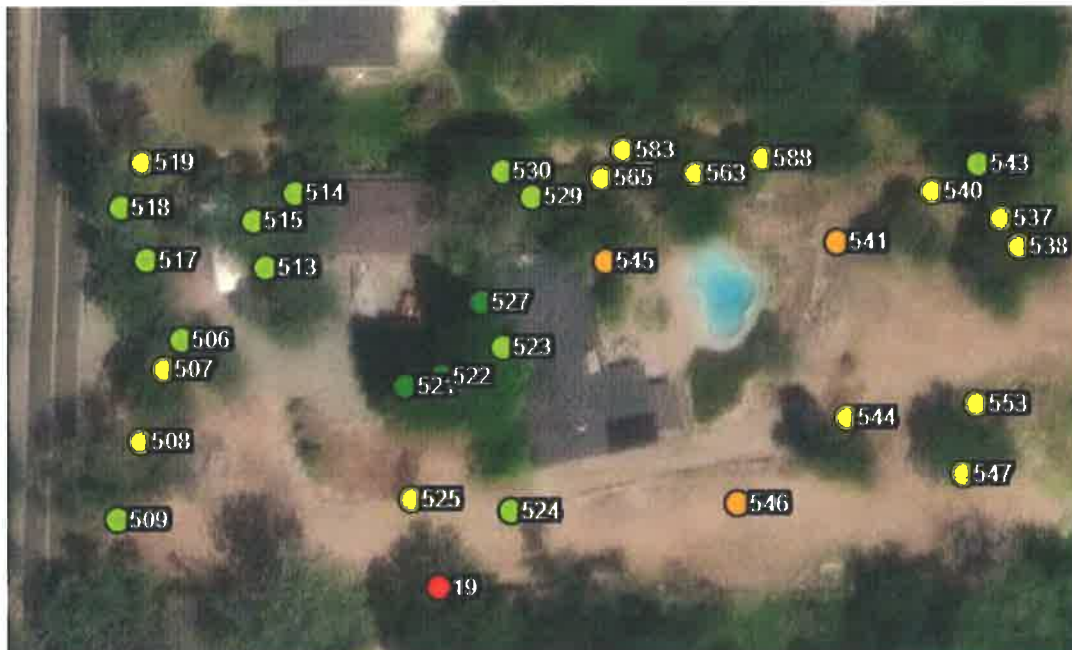
Aerial Image of 7635 Baldwin Dam Rd with Tree #'s in approximate locations

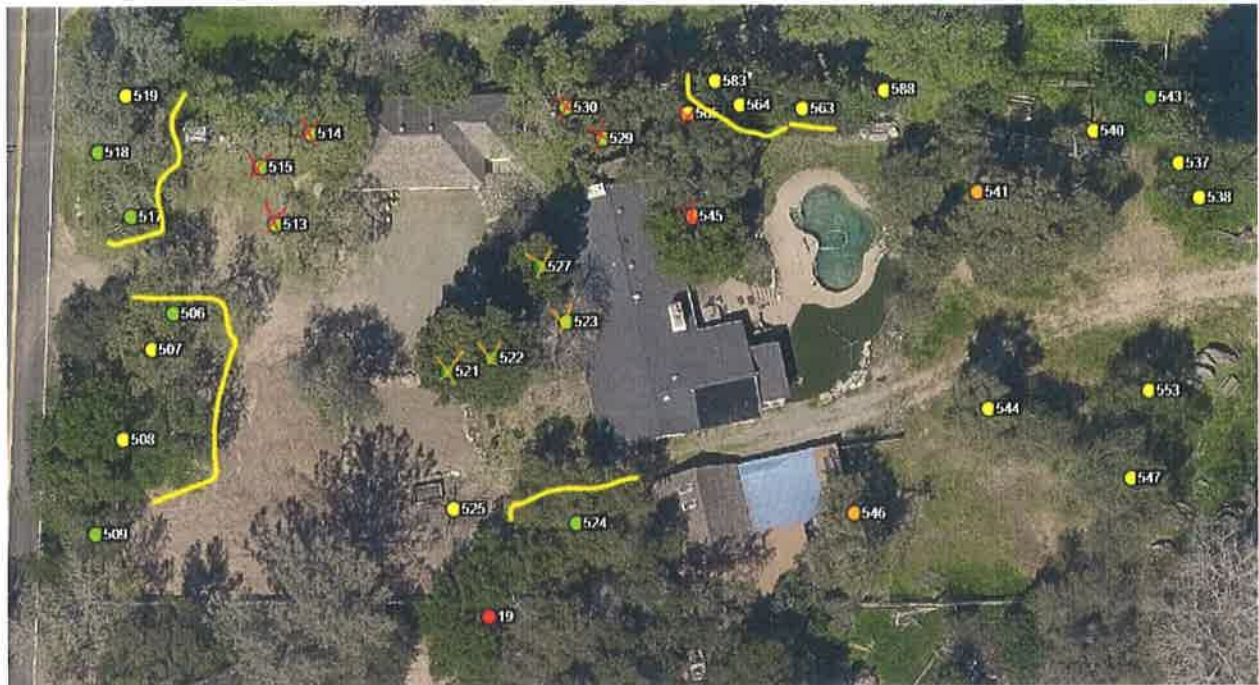
Aerial image showing:

7 protected trees to be removed red X's - 513, 514, 515, 529, 530, 545, & 565

4 unprotected trees to be removed gold X's - 521, 522, 523, 527

Tree protection fencing for trees to remain - yellow lines
