Arborist Report for 110 Landrum Circle Folsom Ca

Summary

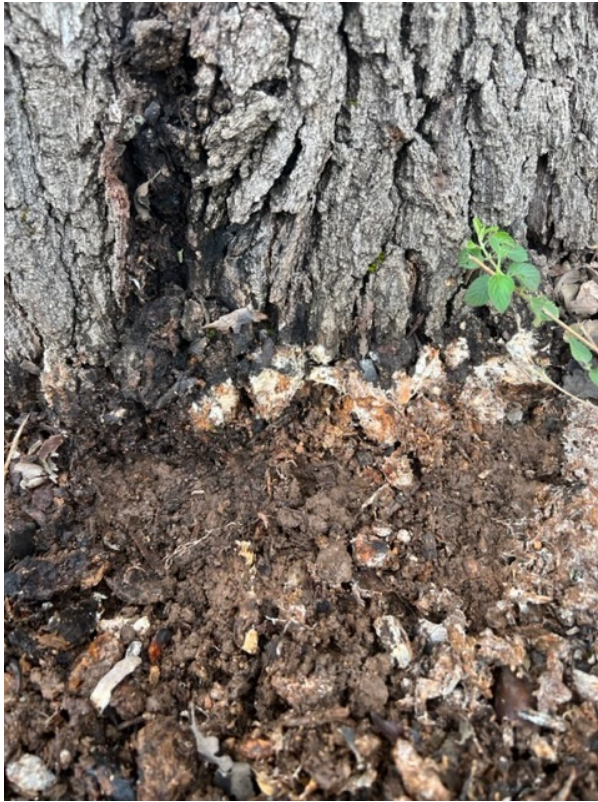
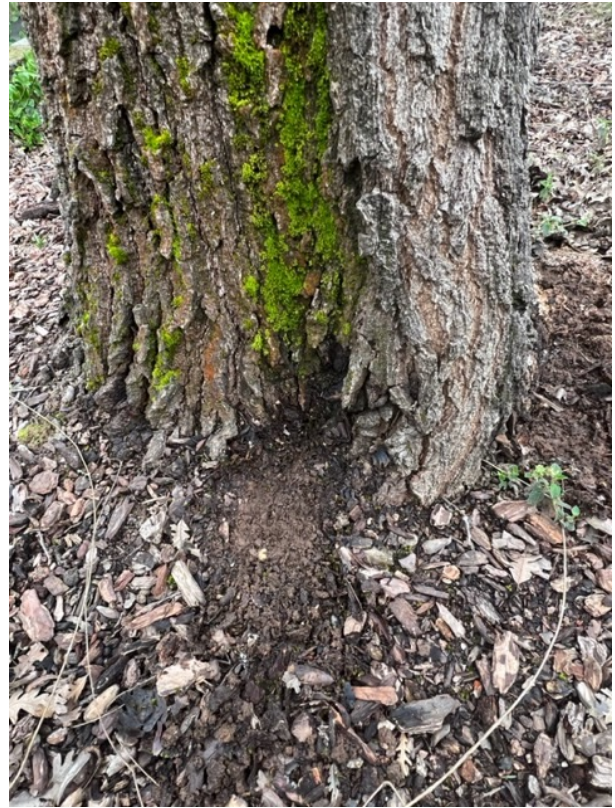
I performed a tree inspection on February 19th at this location. The tree is a Valley Oak, *Quercus lobata*. The tree is in fair health and its' proximity to the house requires a higher degree of identifying possible hazards now and over time. The DBH of this tree is 16 inches.

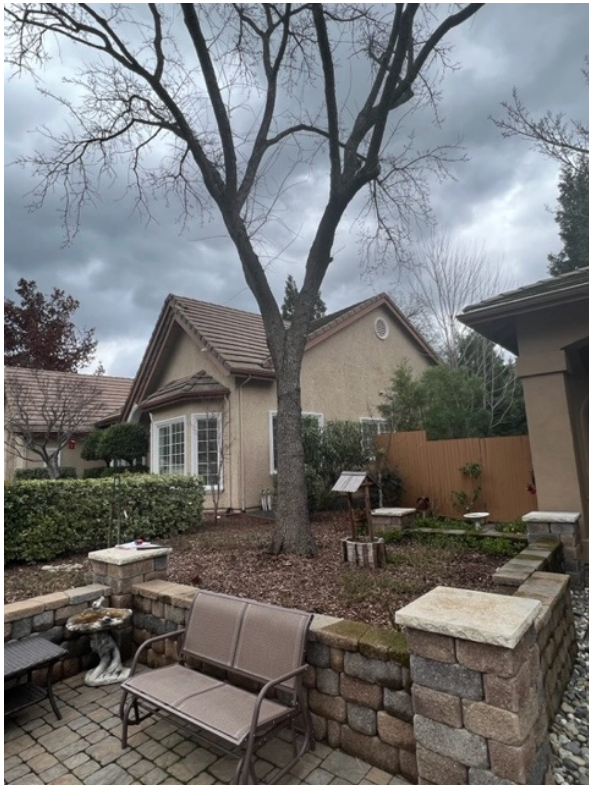
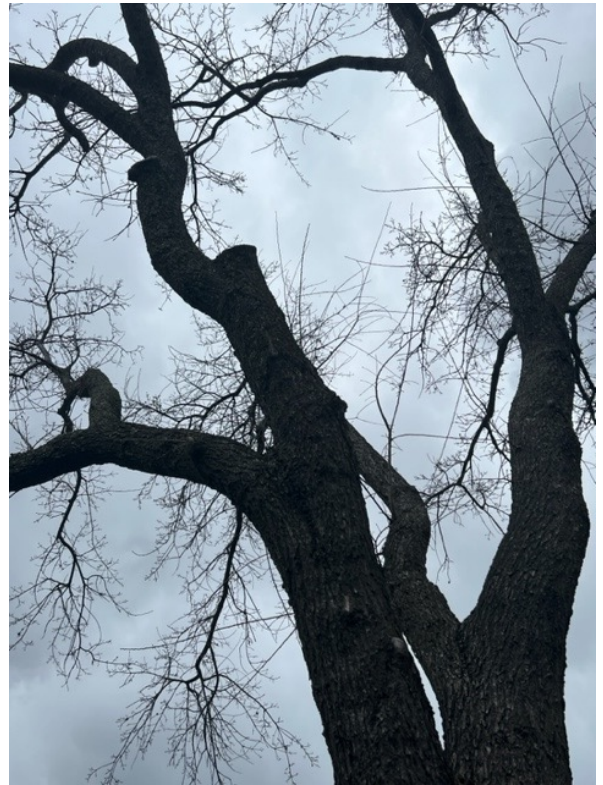
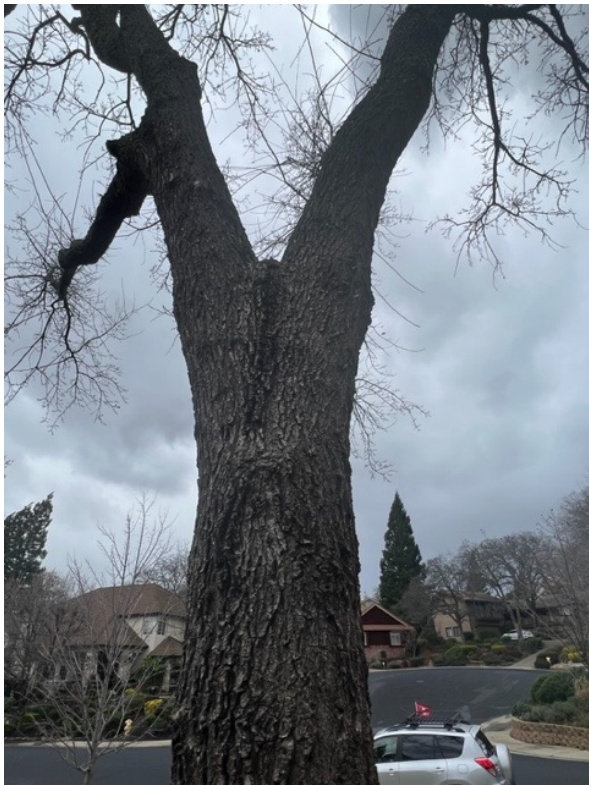
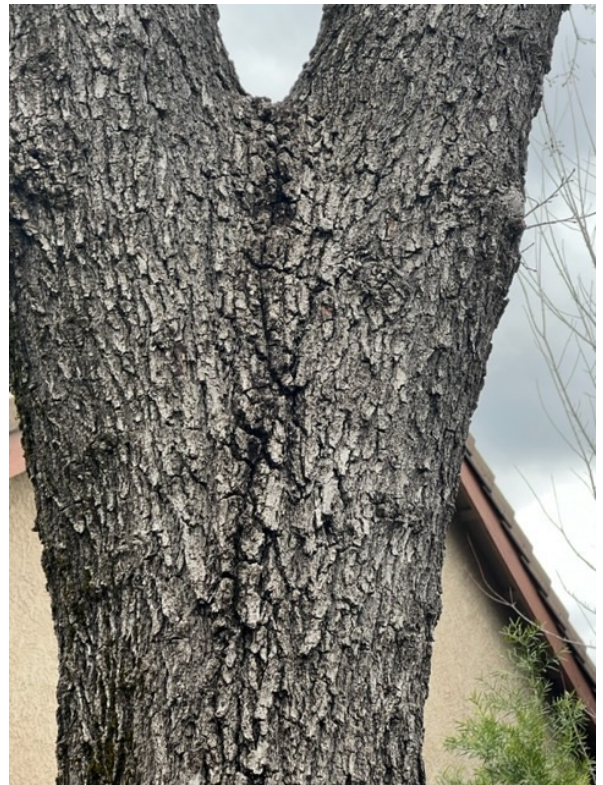
The tree is located in a barked raised bed. This causes a retention in moisture which could lead to fungus and decay. Some fungus was observed and one soft spot at ground level and below was detected. Some sluffing off of bark was also present at ground level. Landscape bark was touching the trunk of the tree and should be raked back at least 12 inches from the trunk.

The location of this tree is in a raised bed contained by concrete pavers. This will limit the future root spreading of this tree which typically have roots under the edge of the canopy and beyond. This could limit the health of the tree and the holding capacity of the anchoring roots as the tree matures. There was some aggressive unauthorized pruning of this tree by the previous owners. Pictured above right you can see one of the large cuts that will never be able to be compartmentalized by the tree. This raises a concern as an entryway for decay. The tree has two main limbs and you can see pictured above have a pretty large area of included bark on both sides. This is a potential major future failure site.

At this moment the tree presents a moderate risk of failure and potential property damage due to its' proximity to the house. Unfortunately there are no corrective actions to reduce the risk. As the tree continues to grow the risks will increase as it puts on bulk and weight and the limited area for the roots in the raised bed area will also increase the failure risk over time. A severe and bad pruning job from the previous owners left little to work with in the canopy moving forward and only increased the risk of failures by creating multiple entry points for future decay. Because of the growing risks over time it is my recommendation to remove this tree.
