# Canopy Tree Consulting LLC

## ARBORIST REPORT

February 19, 2024

**Re: 916 Mormon Street, Folsom CA- APN 070-0102-016**

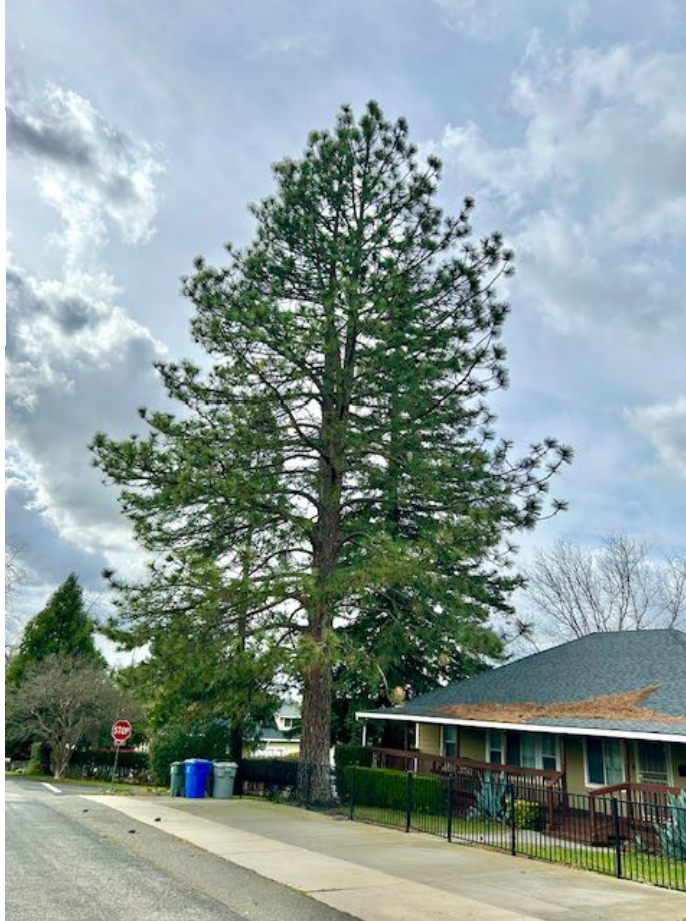
1. The subject tree is a Ponderosa pine (*Pinus ponderosa*). The tree's diameter at breast height (dbh) is 37" and it is 90' tall. Its canopy radius is approximately 30'.

Subject Tree - Ponderosa Pine  
37" dbh, 90' Tall.

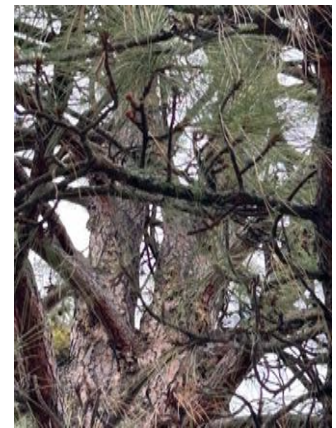
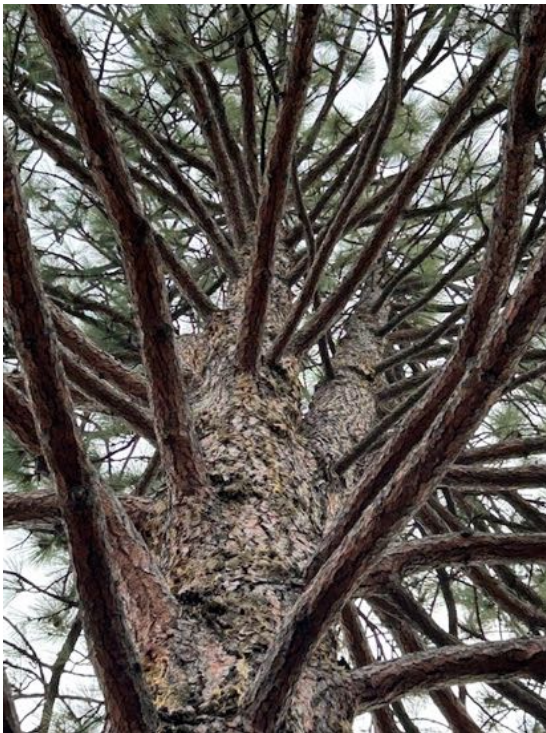
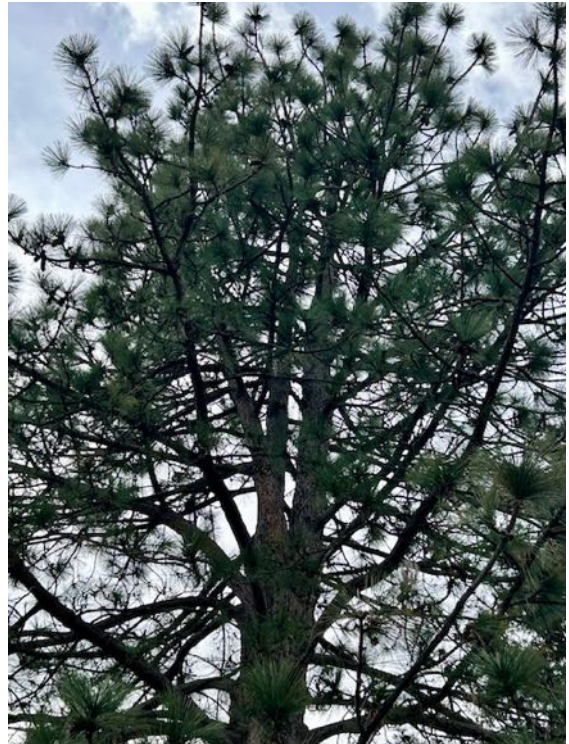
3. There is a water meter and water line located 41" west of the base of the tree.
4. The tree trunk bifurcates into two co-dominant stems that occur at 40'. The fall zone of both 50' long, co-dominant stems includes parts of a home, front yard, home-entrance pathway, sidewalk, driveway, and street.

The fact that the subject tree has two (2) 50' co-dominant top trunk-stems represents a risk of causing serious damage to property and serious bodily harm and/or death to any property or person that is in the impact zone should one of the co-dominant top trunk-stems fail.

- Pedestrians and property are exposed to a level of risk associated specifically to the fact that this tree has a bifurcated co-dominant trunk structure that occurs at 40'.

Bifurcated Codominant top occurs at  
40'.

1. The most effective way to mitigate the risk of property damage or bodily harm caused by needle-sharp pinecones falling from a distance of up to 90' would be to remove the tree.
2. Cabling the co-dominant trunks could be explored in order to reduce the level of risk posed by failure of either of the co-dominant top stems.

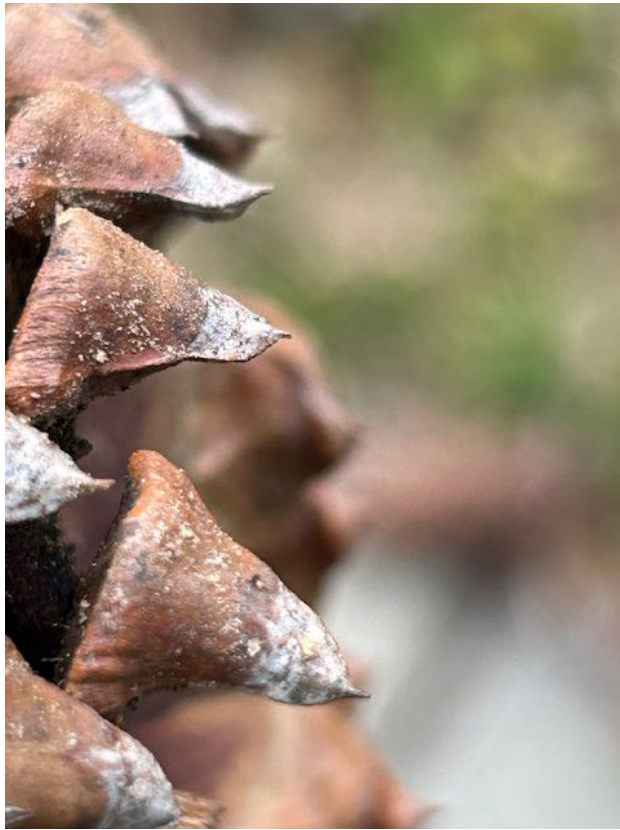
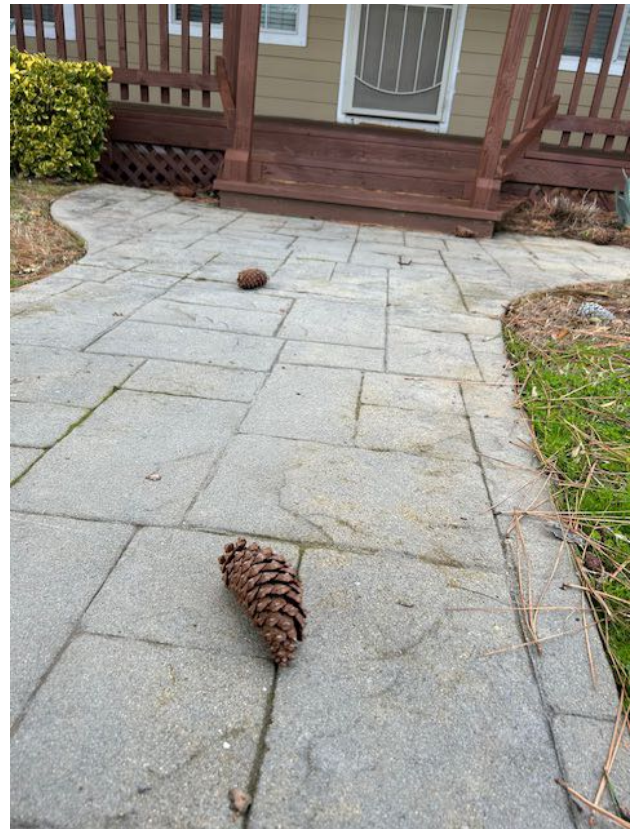
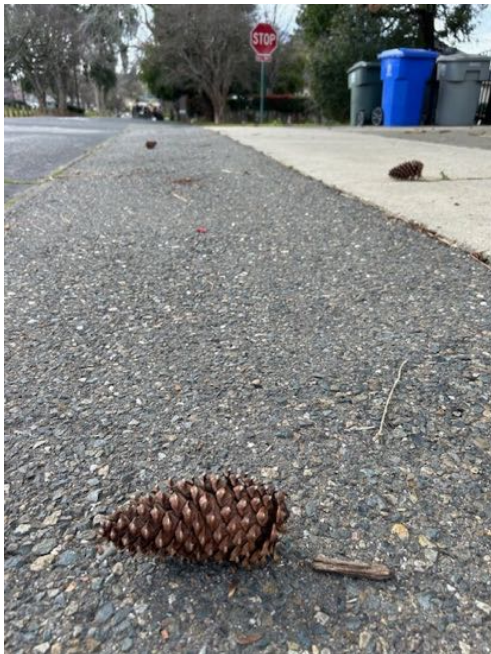
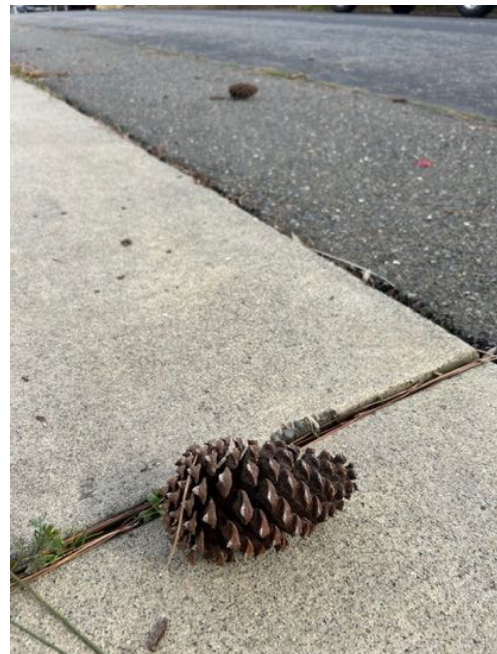
5. From up to a height of 90', needle-sharp pine cones and limbs can drop onto home-entrance pathway, driveway and into the middles on the westbound lane of the street.

It could be argued that the subject tree is not appropriate for its location. This Ponderosa pine is 90' tall and drops needle-sharp pinecones. The impact areas under the tree are occupied by 1.) cars that are parked in the driveway and driving on a city street, 2.) pedestrians who are using the sidewalk, driveway and 3.) residents who are using their front yard or walking to their front door. Any car or person occupying the impact zone is at risk of damage or bodily harm from a falling needle-sharp pinecone.

- Pedestrians and property are exposed to a level of risk associated specifically to the fact that this tree is a species that drops needle-sharp cones from up to 90'.

Top & Bottom: Needle-sharp pine cones on street, driveway and home-entrance pathway can fall from up to 90'

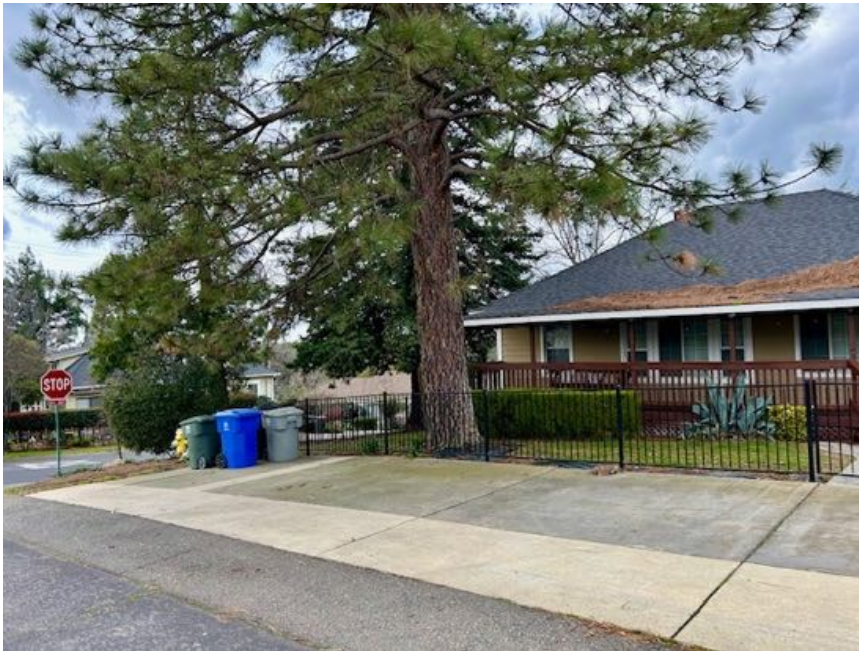
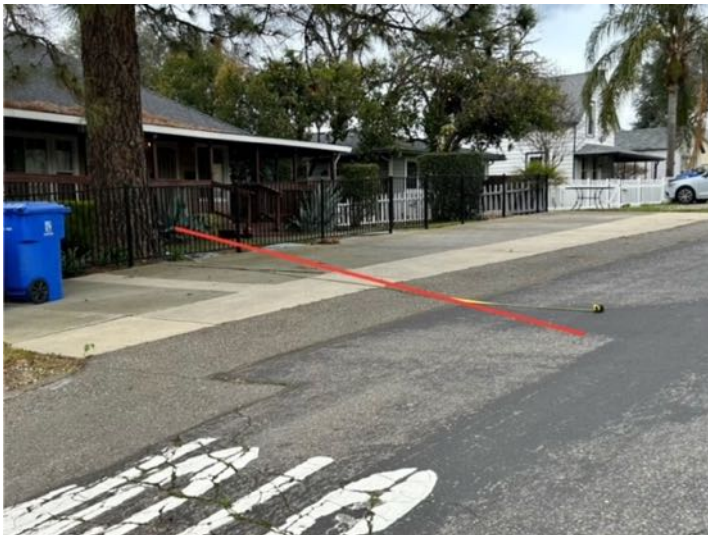
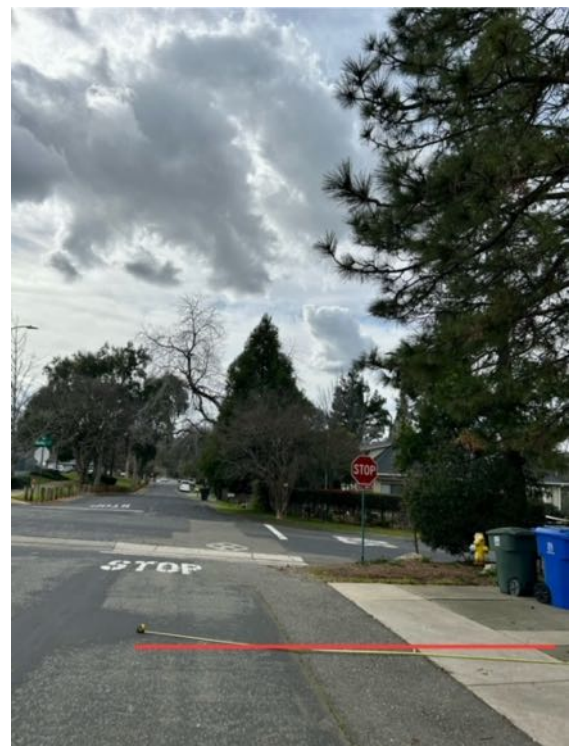
2. The tree is located in the front yard of the property. Its canopy is over parts of the front yard, home-entrance pathway, sidewalk, driveway, and street. The canopy extends to the middle of the westbound lane of Mormon Street.

Top & Bottom: Canopy radius is approx.. 30'. From up to 90', needle-sharp pine cones and limbs can drop onto home-entrance pathway, driveway and into the middles on the westbound lane of the street.

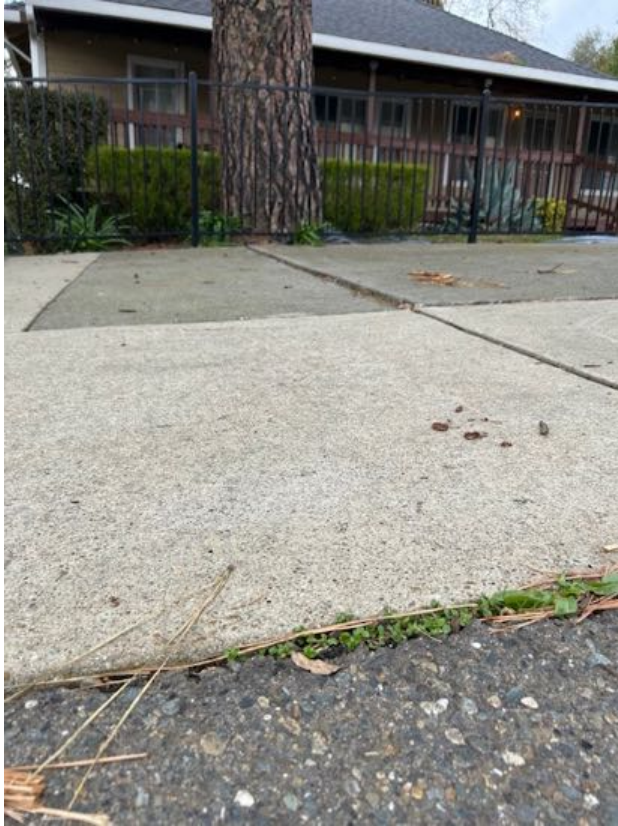
6. Lifting from roots is causing infrastructure damage to a permanent structure; the driveway/sidewalk.
7. The tree could be considered healthy with good vigor and good canopy density. The trunk appeared to be sound at ground level and no significant cavities or cracks were observed on the trunk or in the canopy. No significant limb failures were observed throughout the canopy and no limbs were observed to be overly heavy or extended.

The subject tree's roots are causing damage to an existing permanent structure or feature that includes a combination driveway/sidewalk. According to the language in the City of Folsom's 'Tree Removal Permit Application' document, the tree meets the listed conditions for removal permit approval.

- The subject tree's roots are causing damage to an existing permanent structure or feature that includes a combination driveway/sidewalk. According to the language in the City of Folsom's 'Tree Removal Permit Application' document, the tree meets the listed conditions for removal permit approval.

Left: Lifting from roots is causing damage to a permanent structure; driveway/sidewalk.

3. Installing a root barrier to prevent the lifting of driveway/sidewalk hardscape could be explored. However, the hardscape is located so close to the base of tree that buttress roots may be damaged by the installation of the root barrier. This might compromise the structural integrity of the tree. Moreover, root barriers have been found to be ineffective because adventitious roots will follow the path of least resistance. The trench cut for the root barrier contains loose soil which can lead to roots growing over top or under the root barrier and, eventually, finding their way to lifting the hardscape again.

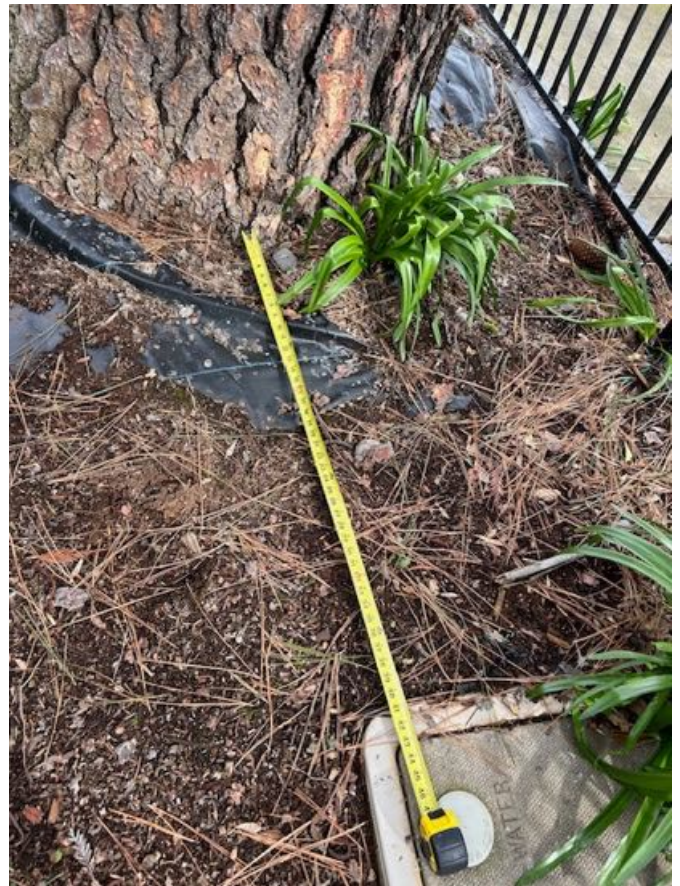
Right: 37" dbh Trunk is 41" from from water meter and water line.
