Invoice

Job Name
Riddle 20240410

Job Site	Salesperson	Terms
111 Lakeside Way	Wayne McKee - WE-0959A	Due On Receipt

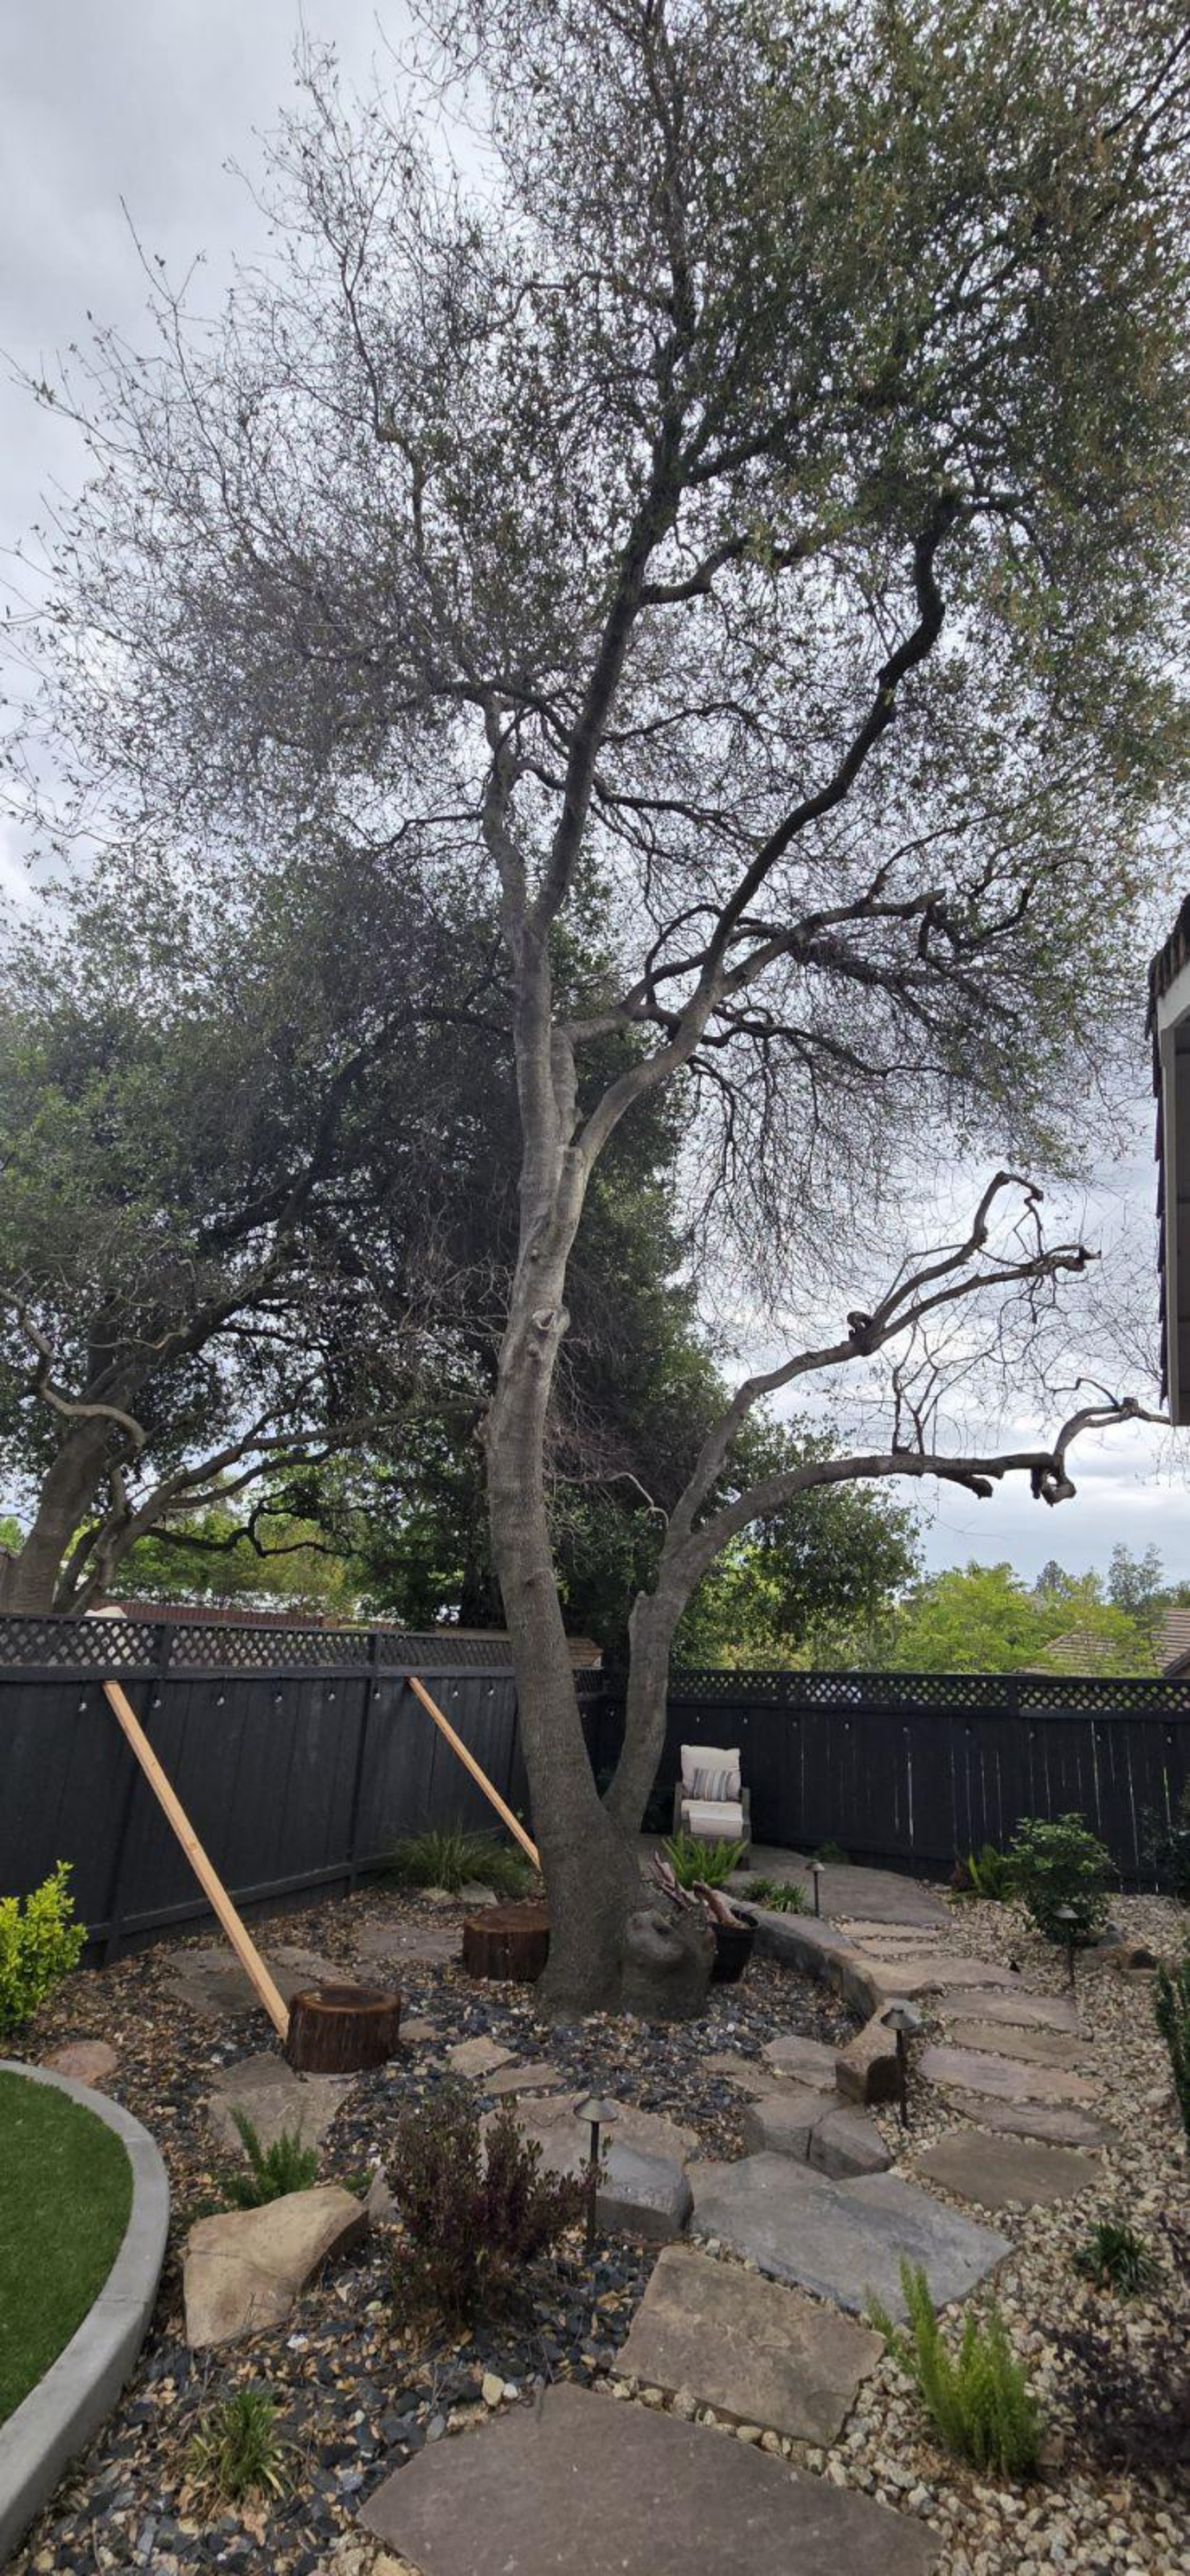
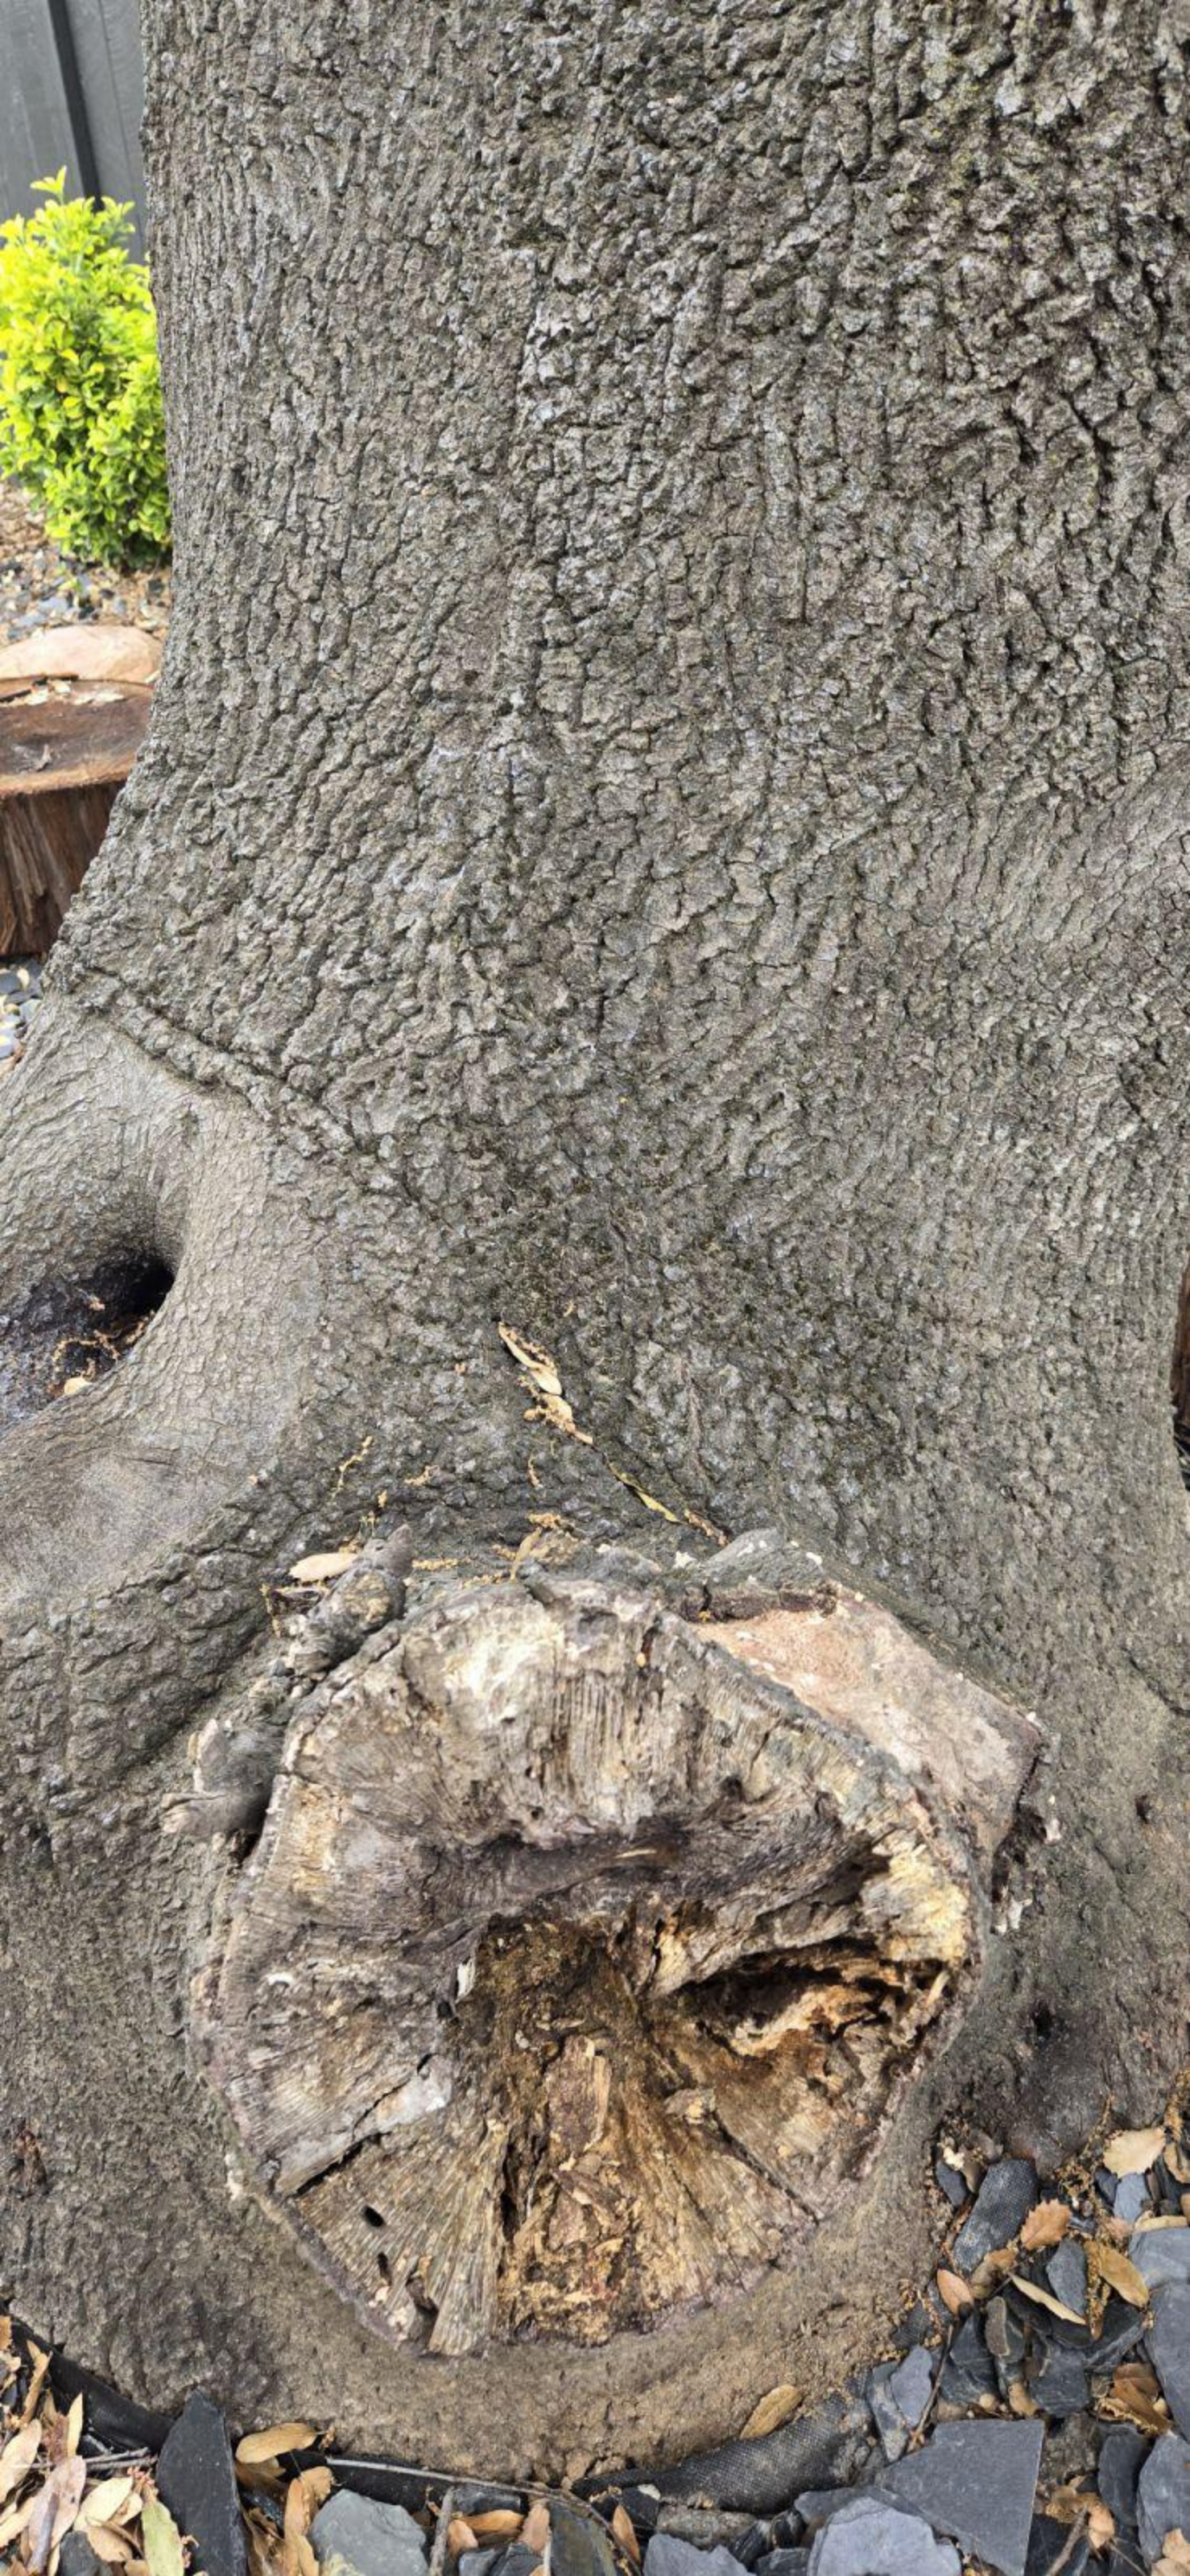
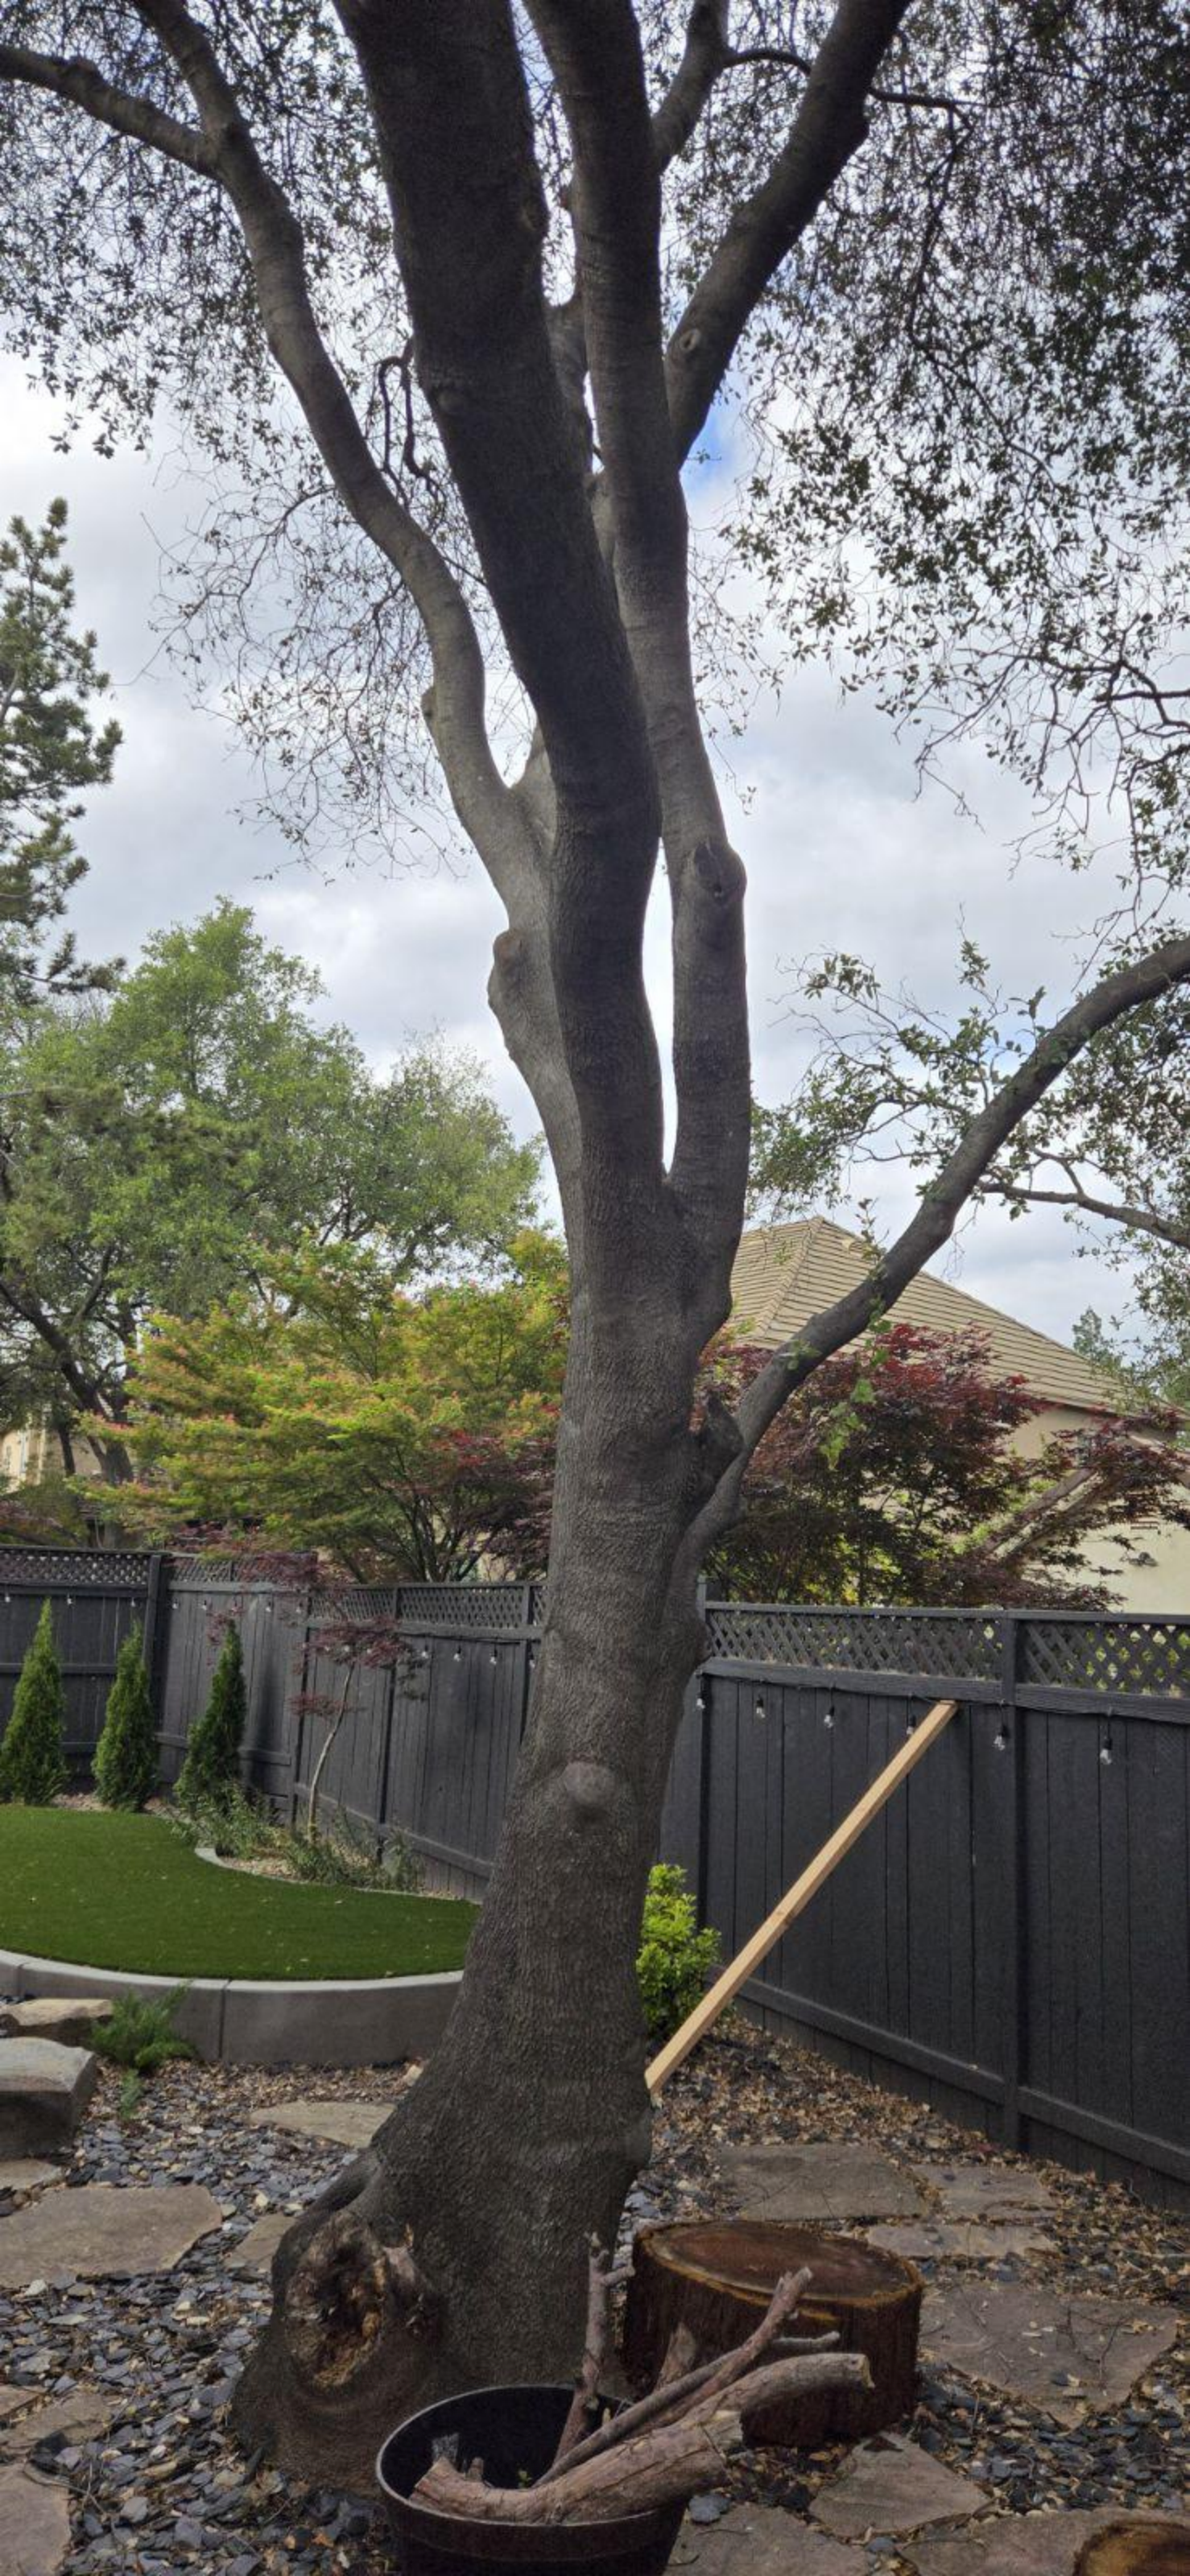
Service	Service Description	Completed
Certified Arborist Services	<p>I met with Darryl on April 9th to evaluate his backyard Interior live oak and sent the following email on 4-10-24.</p> <p>This email is a report of my findings from the inspection on 4-4-24 of the Interior live oak (<i>Quercus wislizenii</i>) located in the backyard of 111 Lakeside Way in Folsom.</p> <ul style="list-style-type: none"> • Interior live oak (<i>Quercus wislizenii</i>): 11 and 17-inch Diameter Standard Height; 20 foot Dripline Radius; poor to fair structure and poor vigor. Located 13 feet west of the structure with canopy overhang. • Notable Characteristics: 12-inch diameter decaying stem attachment west side with evidence of borer activity, callusing basal wound 1 foot above grade west side where a 12-inch diameter stem was removed with a 4-inch diameter cavity opening. Evidence of bark beetle activity in 2 locations on the 17 -inch diameter northerly stem and carpenter worm holes at the base on the east and south sides. Foliage density on the southerly 11-inch diameter stem is 5 percent of average and the foliage density in the northerly stems is approximately 30 percent of average with significant dieback in the canopy of both stems. The ASCA Rating for this tree is 1. • Recommendation: Due to the significant decline in the tree's vigor and evidence of damaging boring insects with no effective mitigative treatments, removal is recommended. 	4/9/2024
