Arborist Survey Report

Z Global - 603 Sutter Street

Folsom, California

March 12, 2019

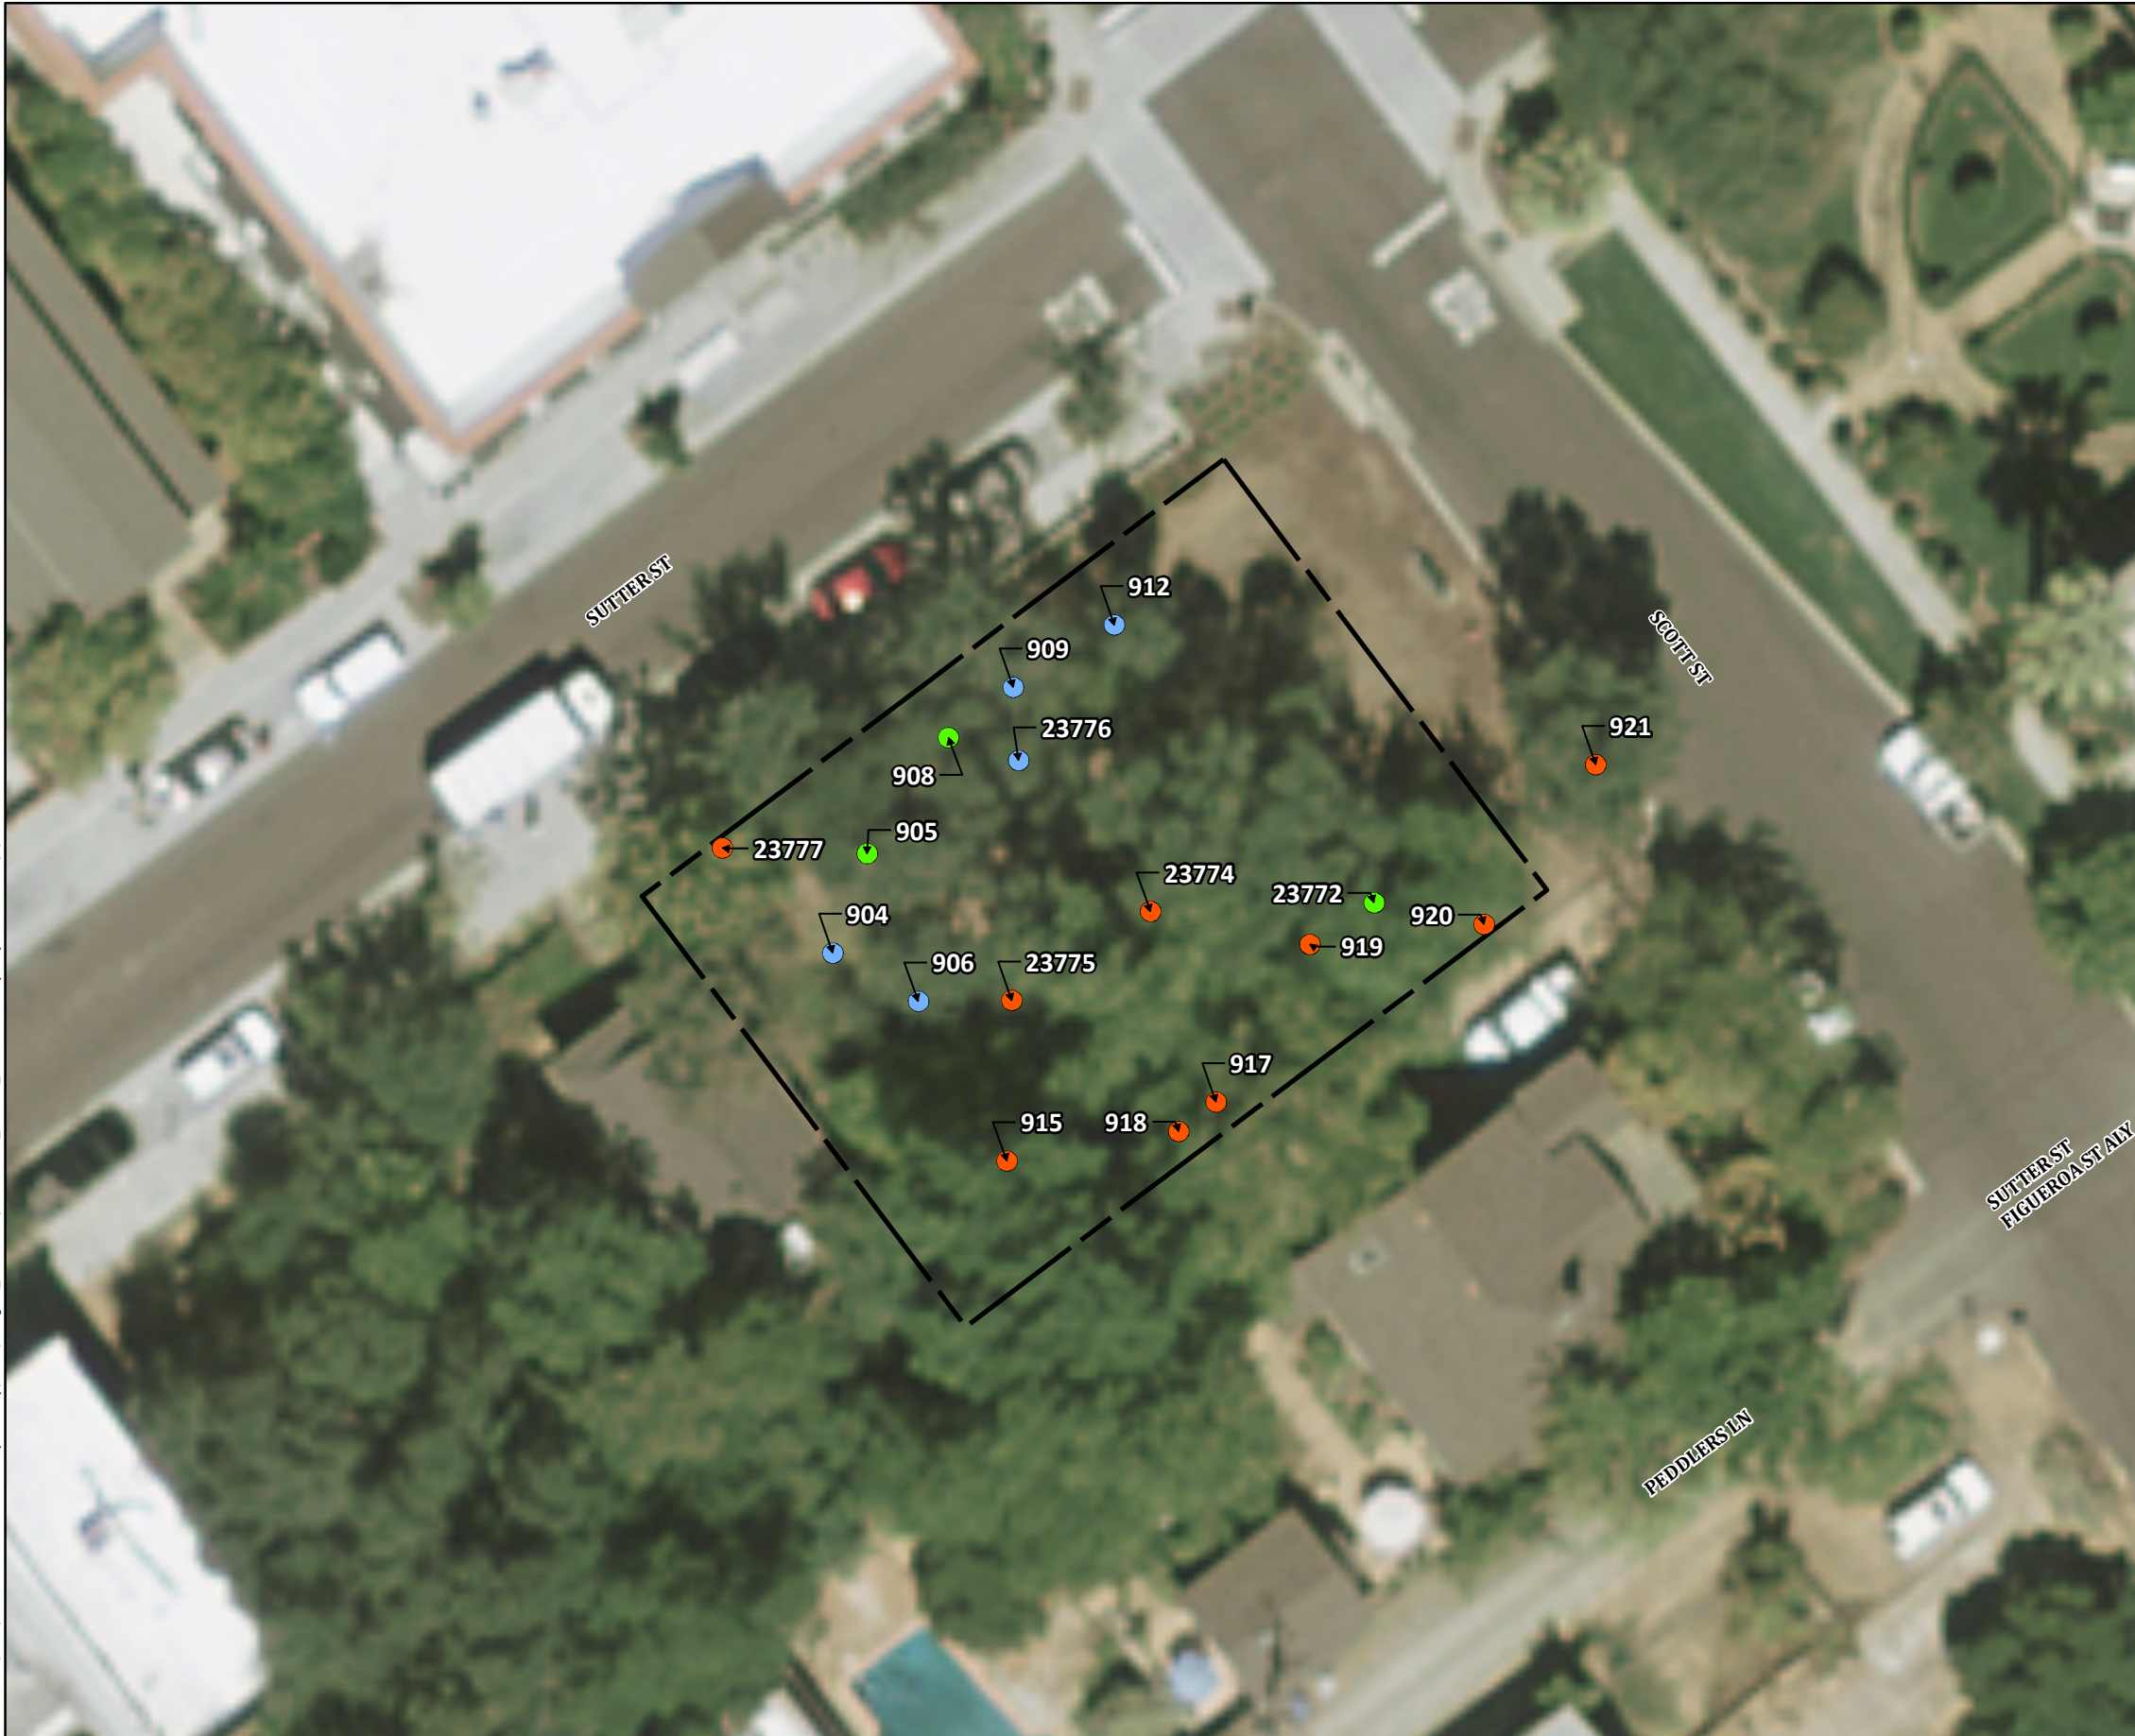
Attachment A - Tree Inventory for 603 Sutter Street

Within the parcel boundary there are 16 native oak trees representing three species: eight valley oaks, five blue oaks, and three interior live oaks. Additionally, there are four horticultural trees within the parcel boundary, which are all species of *Prunus*.

Outside of the parcel boundary there is one valley oak and one horticultural camphor tree.

The parcel boundary and lot contain 17 native oak trees. Sixteen of the native oak trees meet the definition of “Protected Trees” under the Folsom Tree Preservation Ordinance. One oak tree (tree tag #919) does not meet the definition of “Protected Tree” because its DBH is less than six inches.

Impacts to any of these trees will require the preparation and implementation of a tree mitigation and preservation plan. Mitigation may be required if any protected trees are removed.

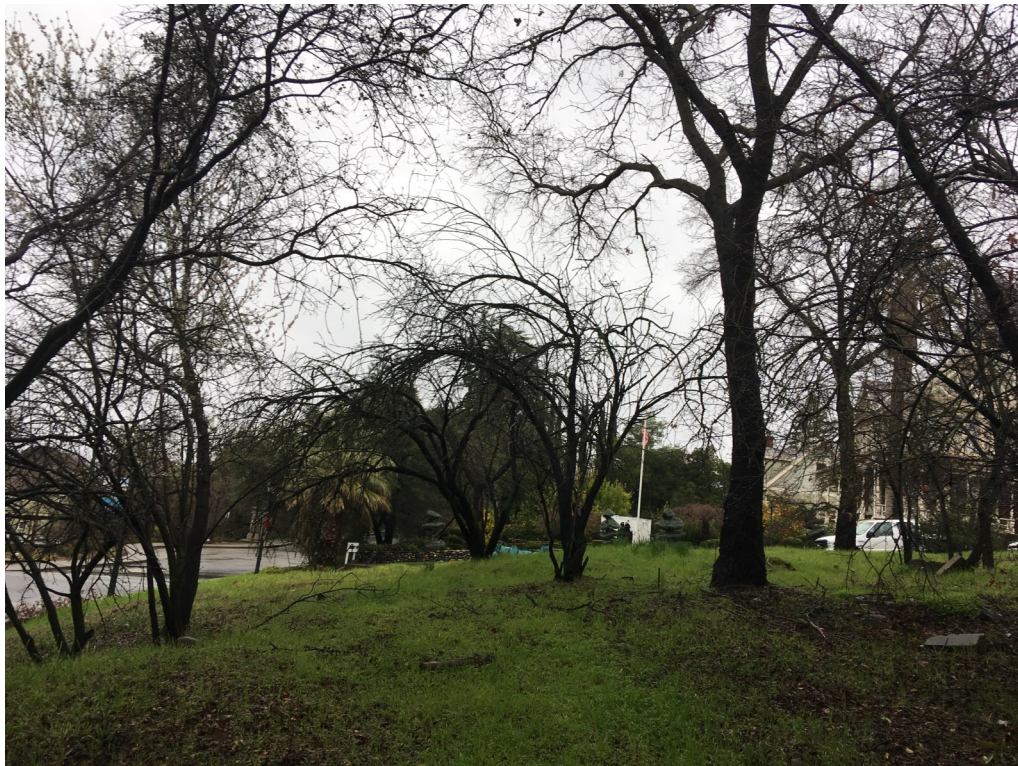
View east. Photo taken February 26, 2019.

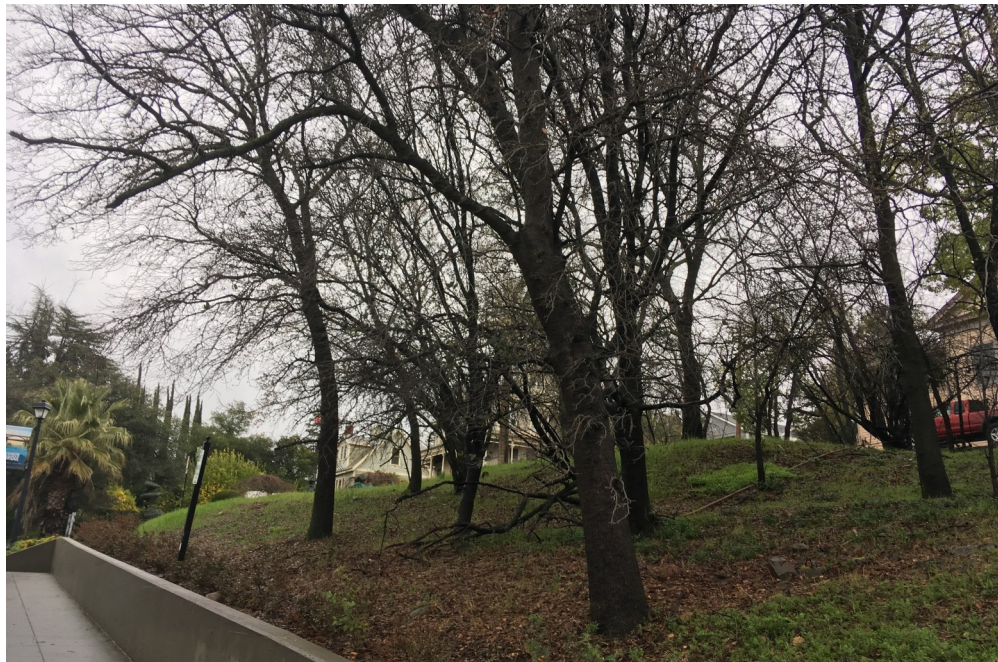
View southeast. Photo taken February 26, 2019.
