ARBORIST REPORT

April 19, 2024

Re: 724 Townsend Court, Folsom CA - APN 072-3320-052

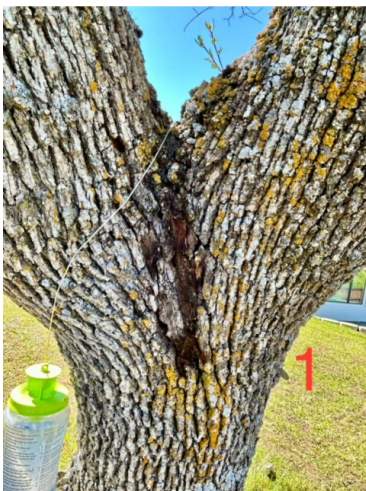
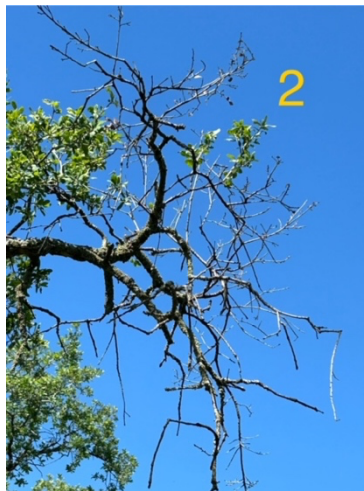
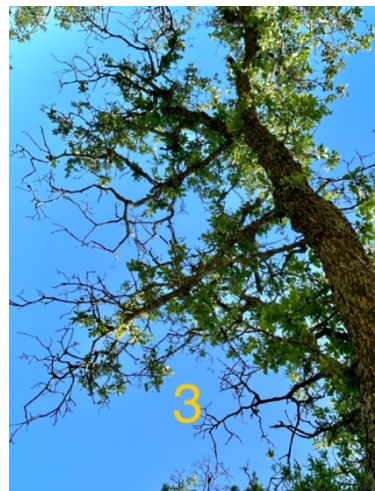
Photos: Evidence of decline in subject trees.

1. The subject trees are all protected native oak trees located in the backyard of what is the southeast corner of the parcel.
2. All three (3) trees are in a significant to severe state of decline and were all given an arborist rating of '2' (significant structure or health problems)

1. The most effective way to mitigate the potential risk of property damage or bodily harm associated with tree hazards would be to remove the trees.
2. Some of potential risk of property damage or bodily harm associated with tree hazards could be mitigated by retaining a qualified contractor to clean the trees' canopies of dead twigs & branches > 1" in diameter along with reducing end weights on heavy, extended branches.

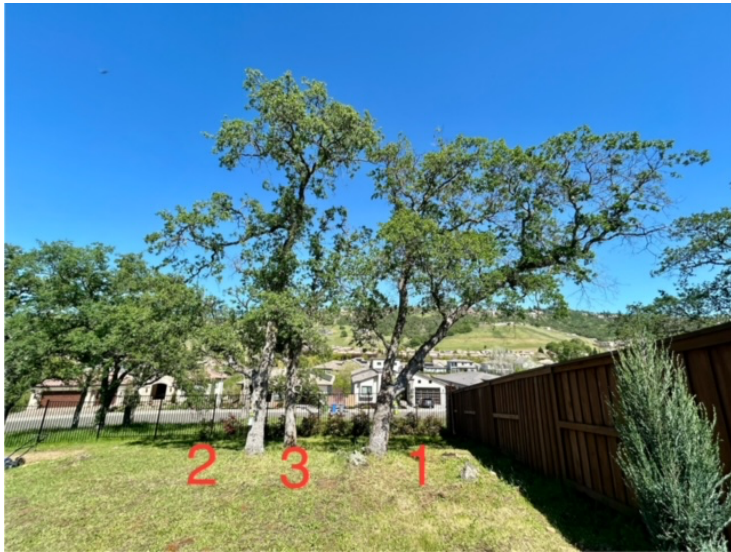
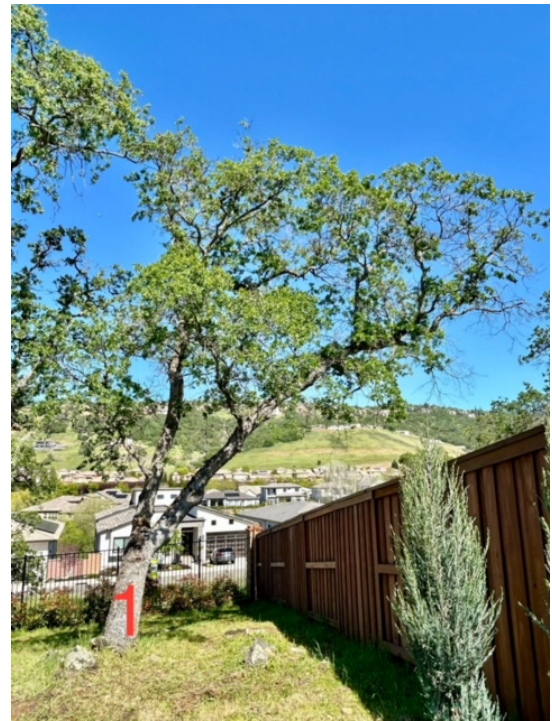
Top Left & Right:
Subject trees – view facing east.

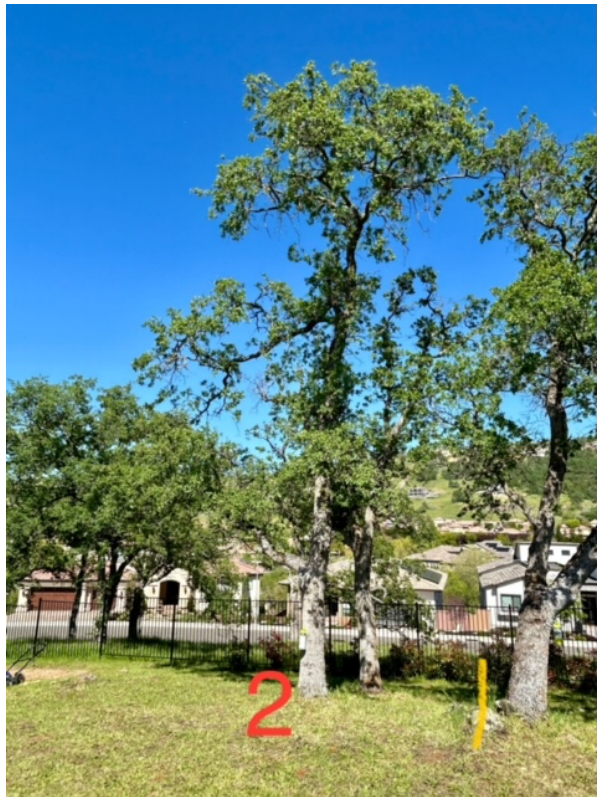
4. Tree #2 – 13.5" dsh, blue oak:
 - Tree in severe decline. Buried flare. Codominant at 5 with significant inclusion and bark decay at the seam. Trunk cavities, woodpecker holes. Bark decay throughout trunk and branches. Borer damage. Severe dieback, epicormic growth on trunk and branches. 4" dead limb south at 12'.

Tree #2 – View facing east.

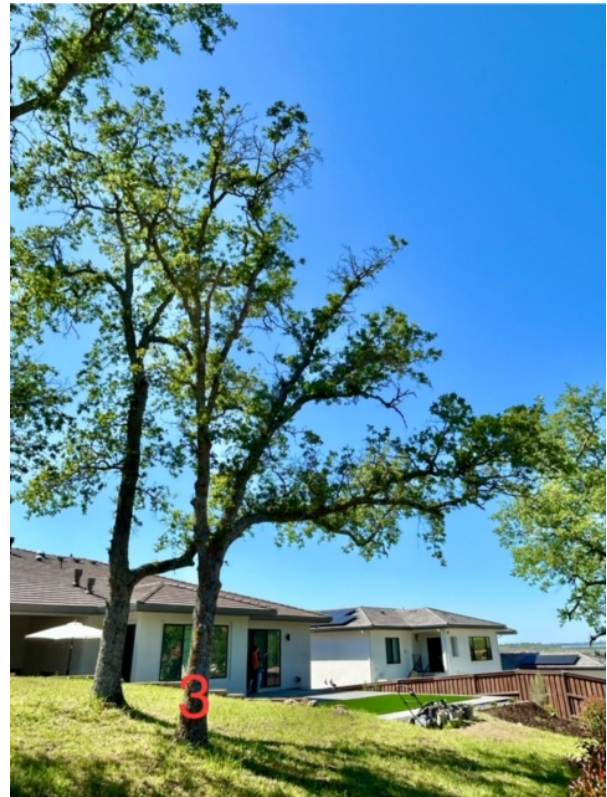
5. Tree #3 – 12.5", blue oak:
 - Tree in severe decline. Buried flare. Bark decay all around root collar. Bark decay throughout trunk and branches. Borer damage. Severe dieback, epicormic growth on trunk and branches.

Tree #3 – View facing west.

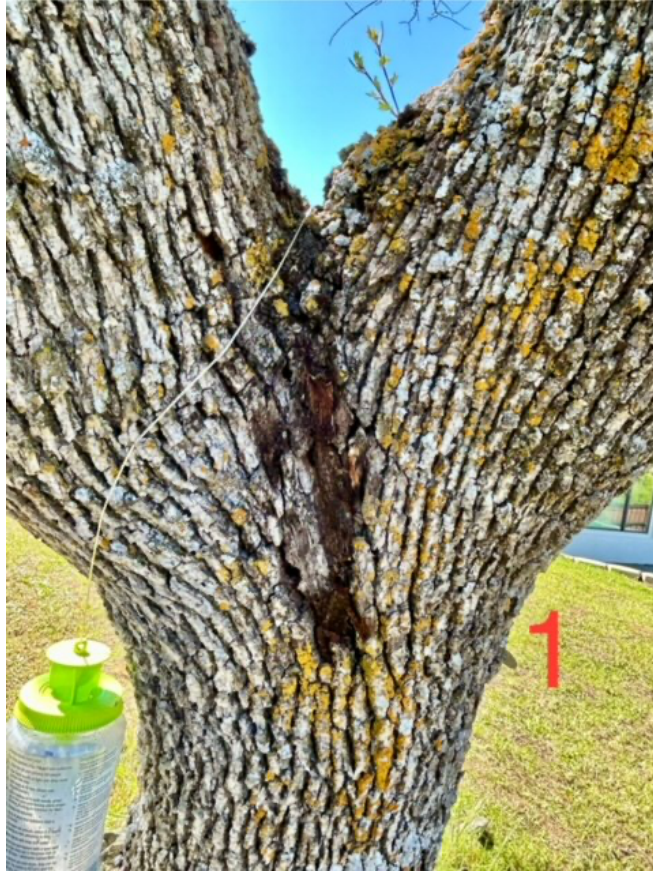
3. Tree #1 – 17" dsh (diameter at standard height), blue oak (*Quercus douglasii*):
 - Tree in significant decline. Buried flare. Codominant at 5 with significant inclusion and bark decay at the seam. Bark decay seam lower trunk south. Bark decay throughout trunk and branches. Borer damage. Severe dieback, epicormic growth on trunk and branches.

6. There is a six (6') foot tall wooden fence located nine (9') feet south of tree #1. A 14" diameter codominant stem is overhanging the fence. The limb is heavy and extended and its junction to the trunk may be compromised by included bark and decay at the seam.

Top- Included bark, Decay seam.

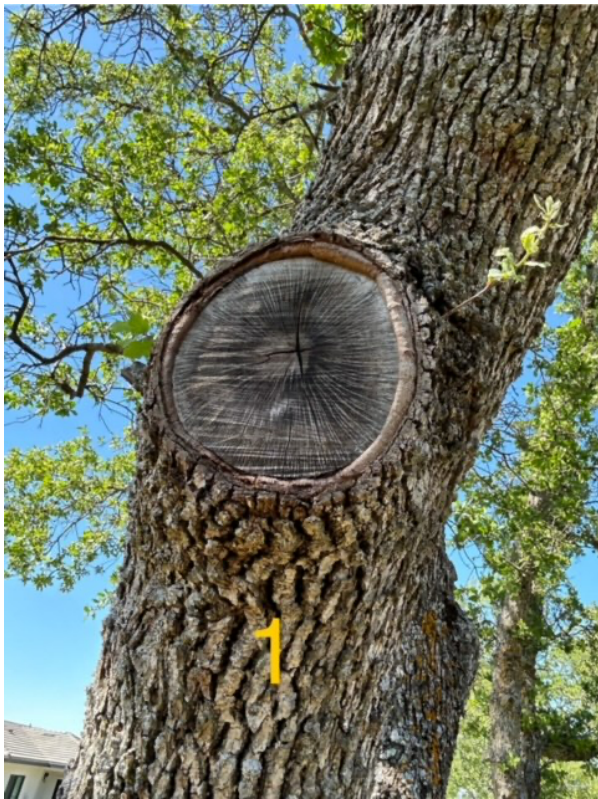
Bottom Left- Large pruning wound.

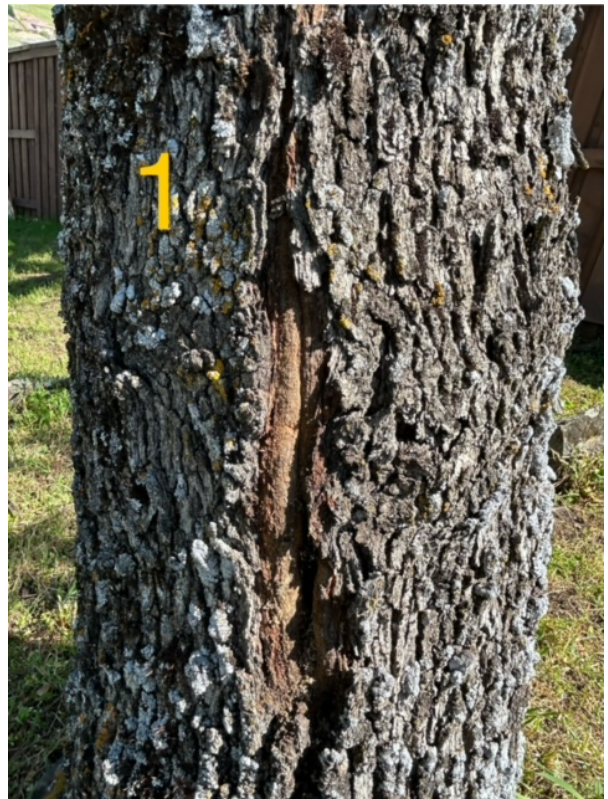
Bottom Right- Bark decay seam.

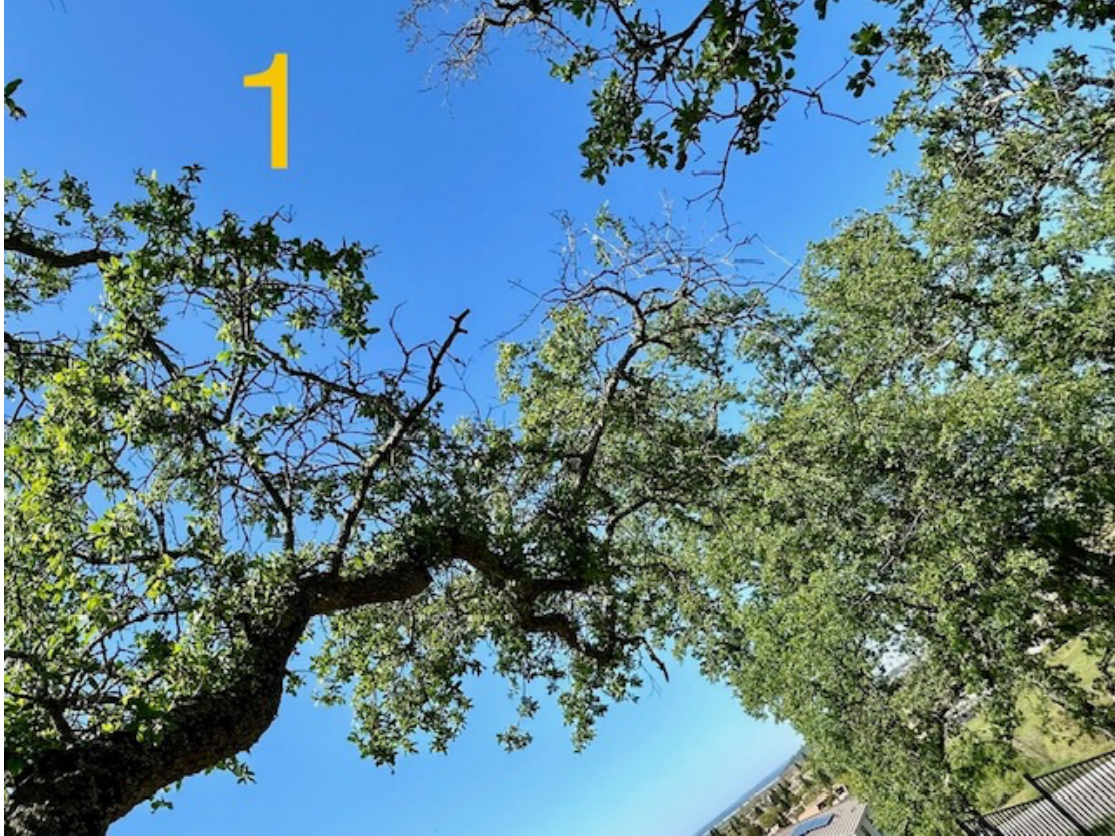
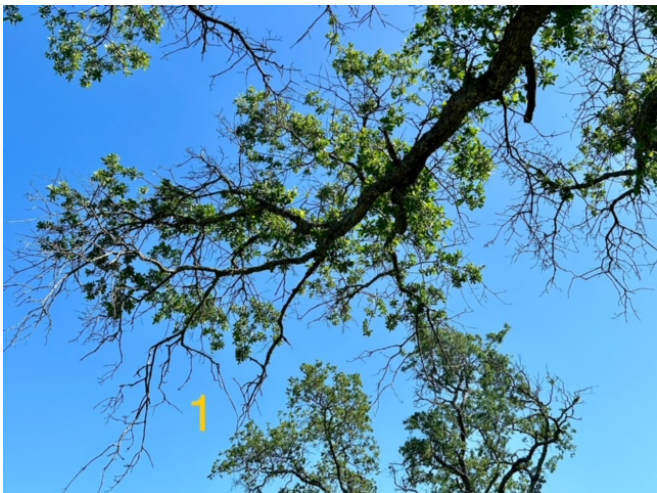
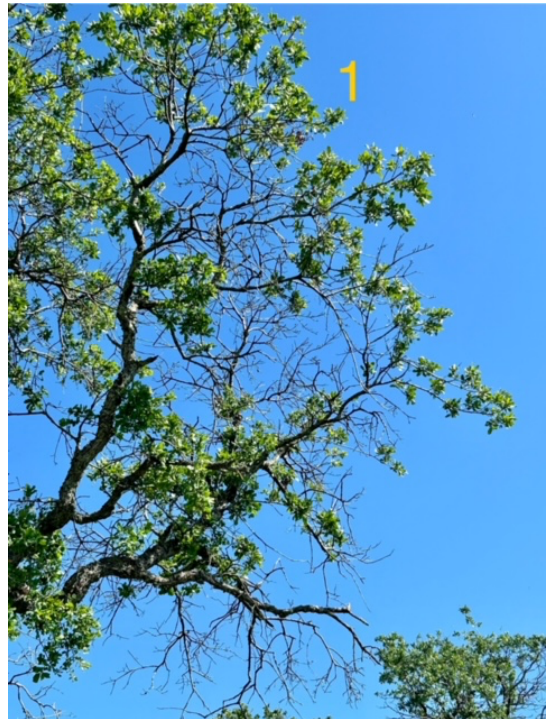
Tree #1:
All Photos- Epicormic growth, Canopy dieback

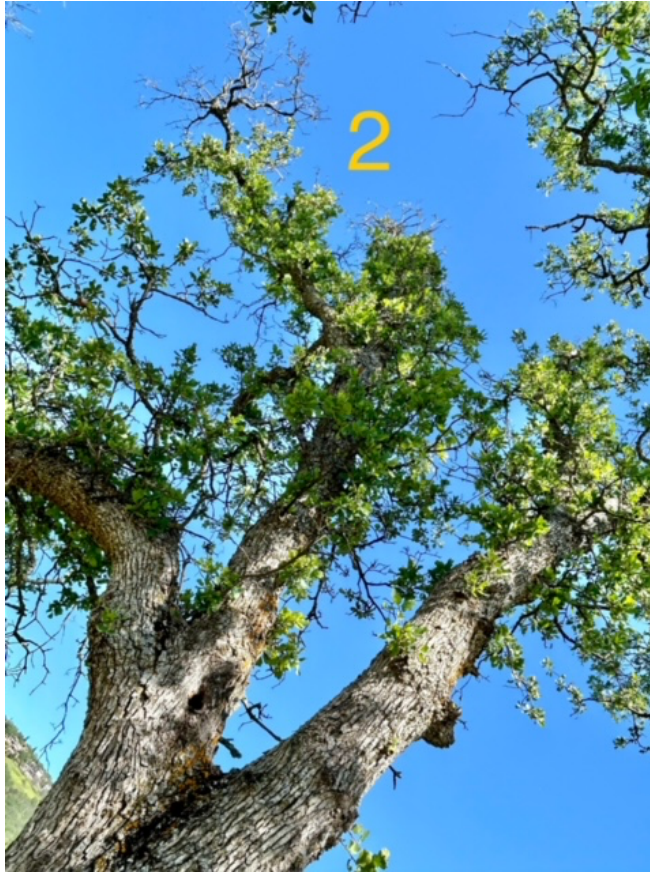
Tree #2

Top- Epicormic growth.

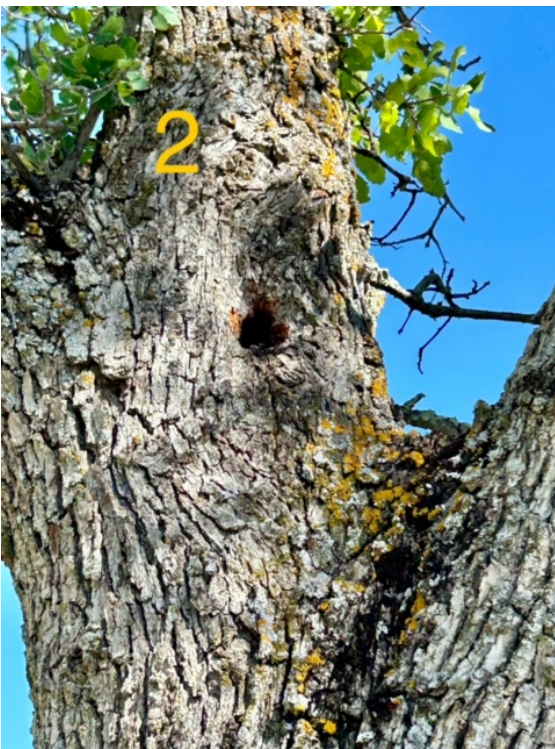
Bottom left- Trunk cavities.

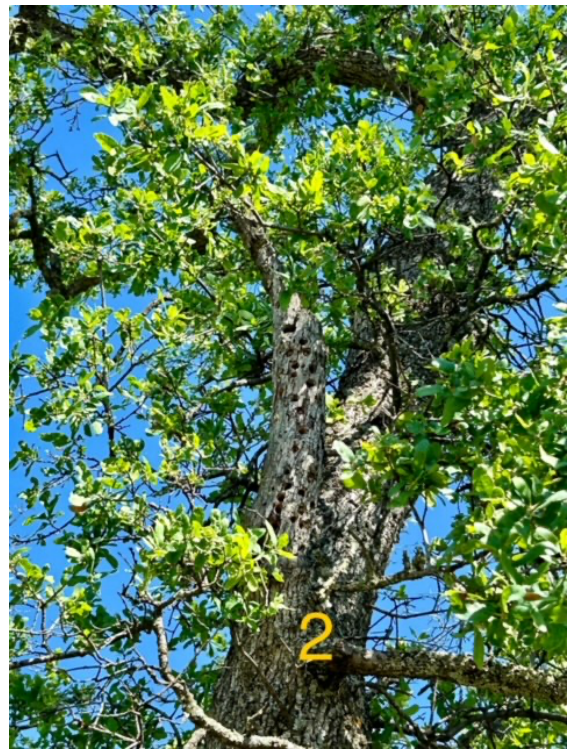
Bottom Right- Dead leaders.

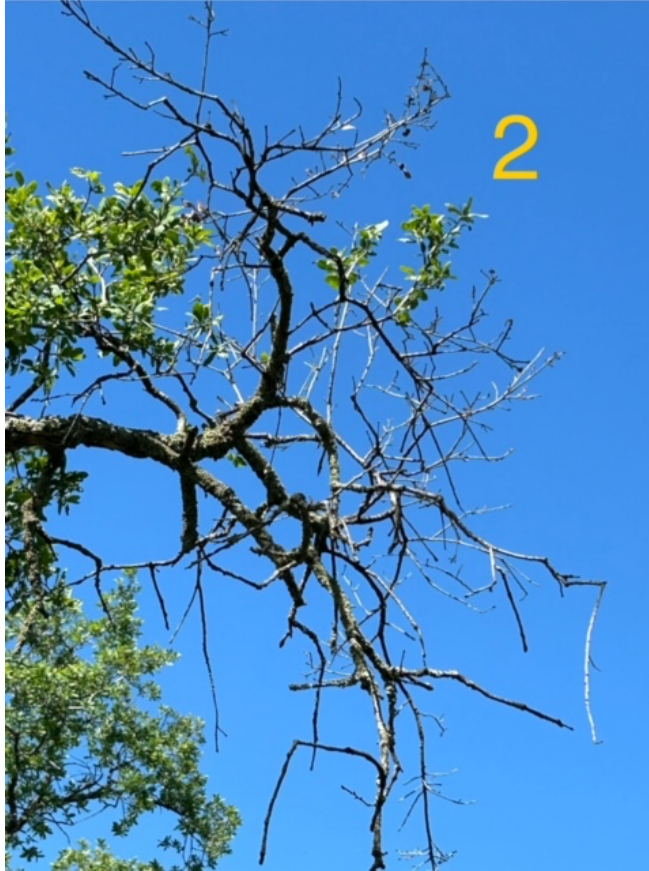
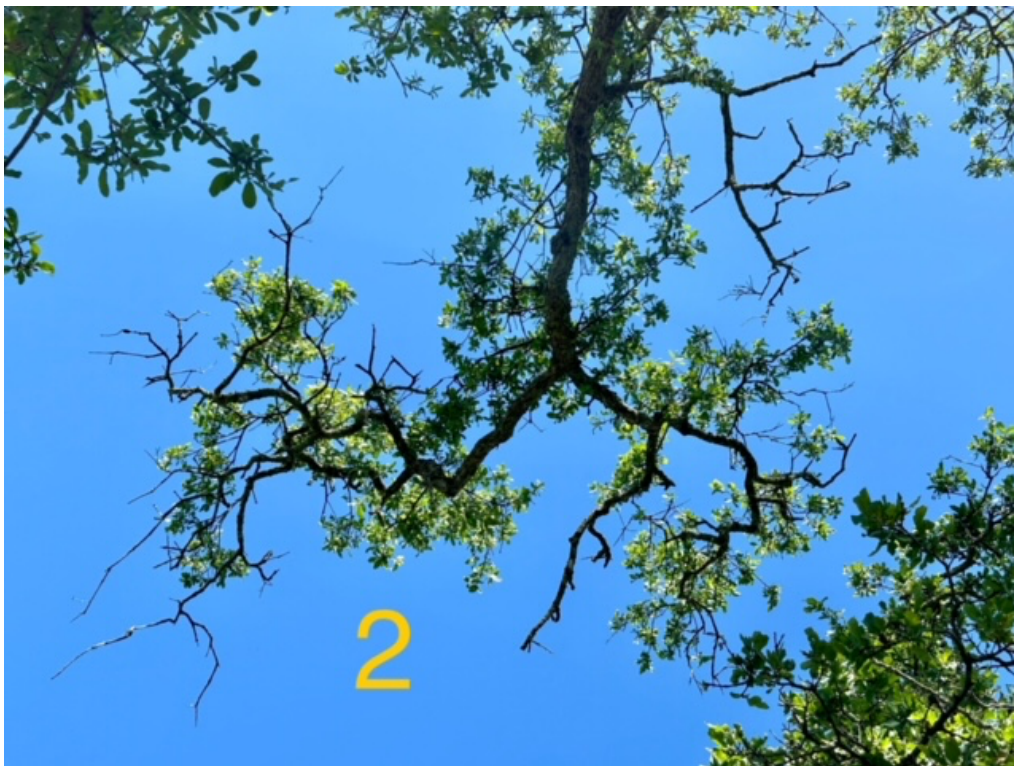
Top & Bottom- Canopy dieback.

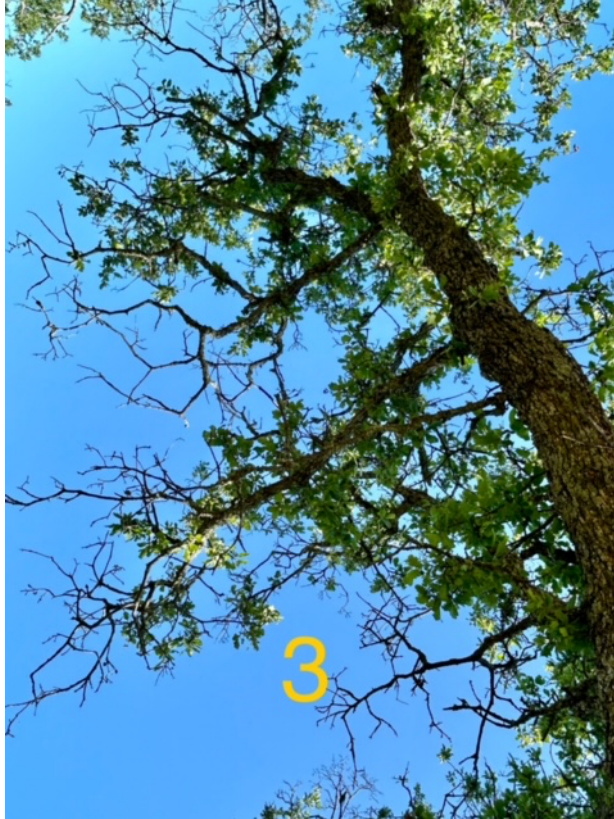
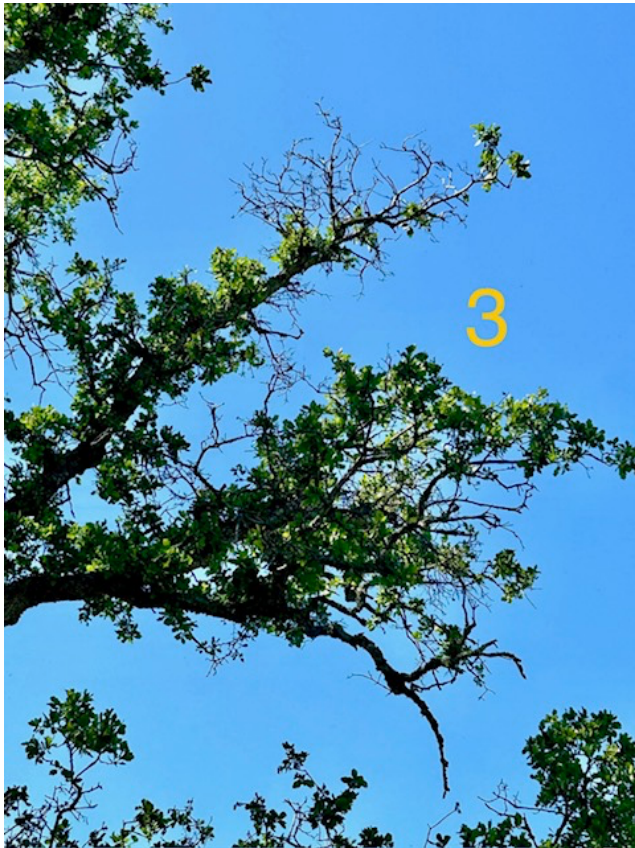
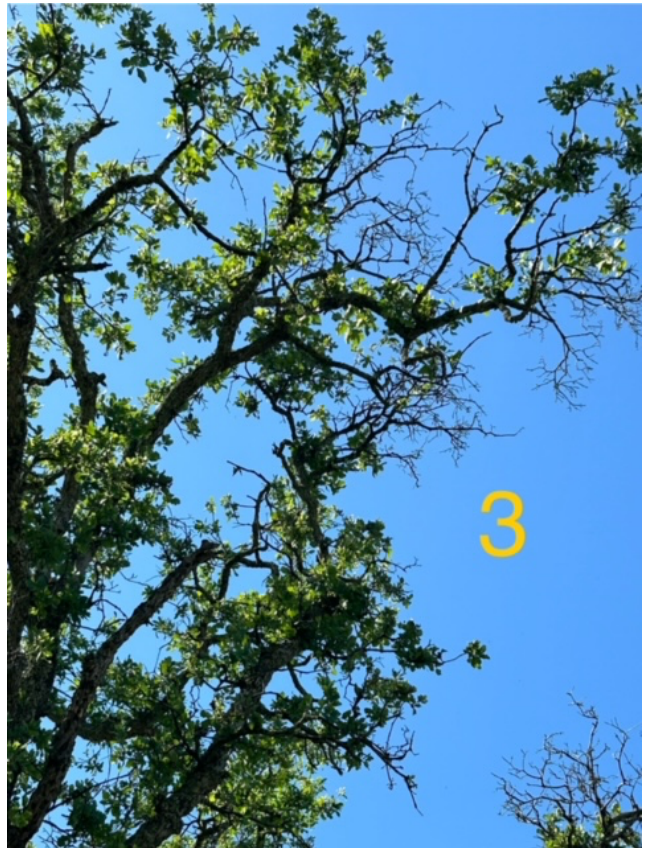
Tree #3

Tree #3:
All Photos- Epicormic growth, Canopy dieback
