California Tree and Landscape Consulting, Inc.

August 22, 2022

RE: ARBORIST REPORT FOR HOME REMODEL AT 7635 BALDWIN DAM ROAD, FOLSOM

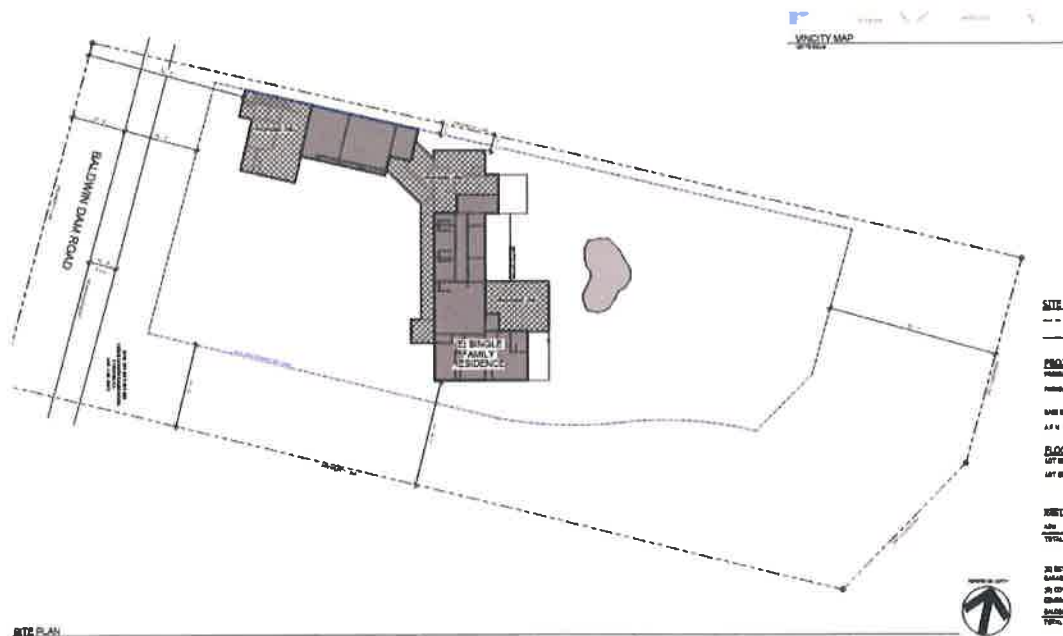
4 unprotected trees to be removed gold X's - 521, 522, 523, 527

Tree protection fencing for trees to remain - yellow lines

Home remodel plan showing layout
