Subject: **SUTTER STREET (603)**
603 Sutter Street, Folsom, California
GEOTECHNICAL ENGINEERING STUDY UPDATE

**GEOTECHNICAL ENGINEERING STUDY
FOR
SUTTER STREET (603)
603 Sutter Street
Folsom, California**

Project No. E17056.000
March 2017

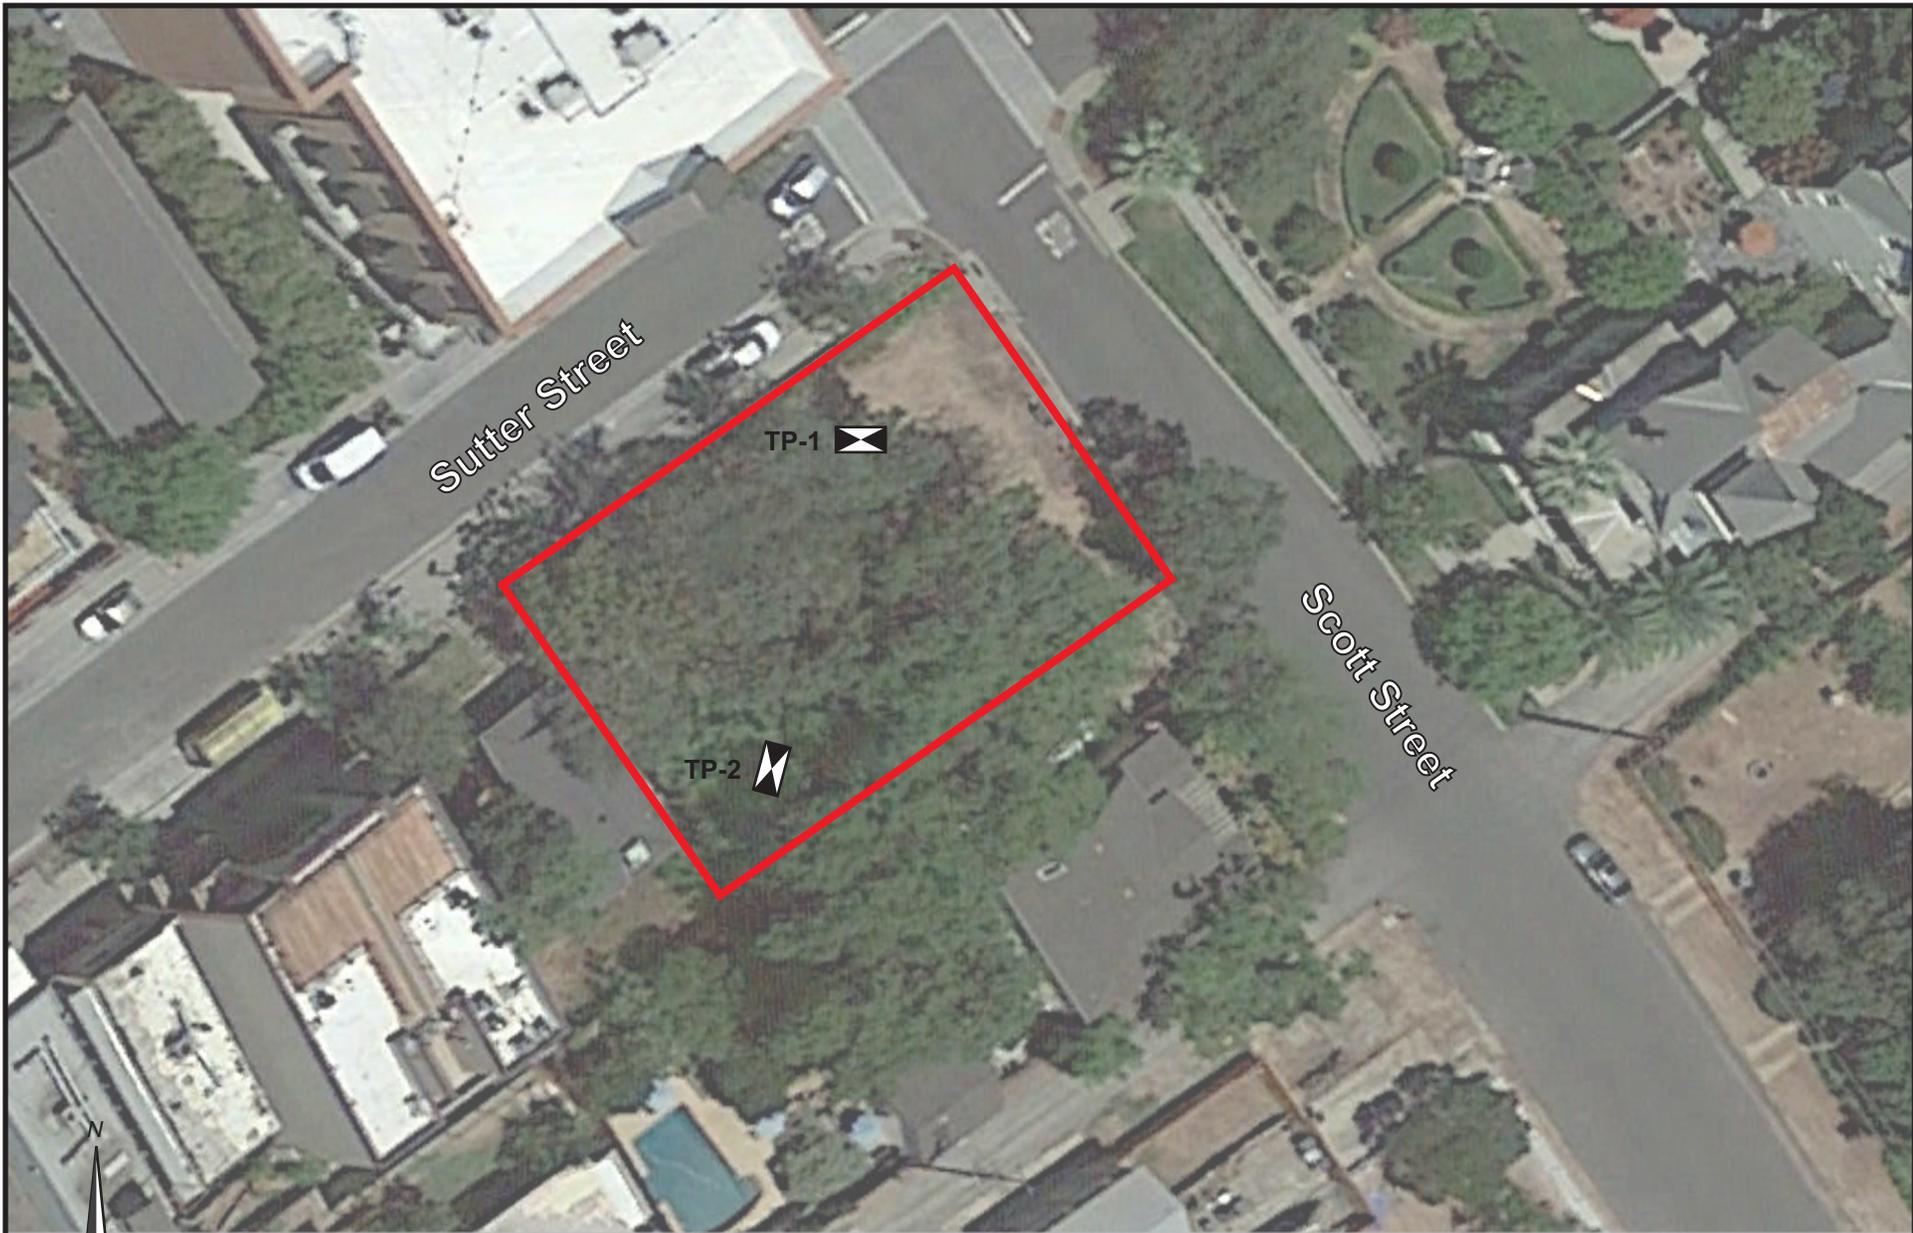
BASE MAP REFERENCE: U.S.G.S. 7.5 Minute Topographic Series, Folsom Quadrangle, Dated 2015

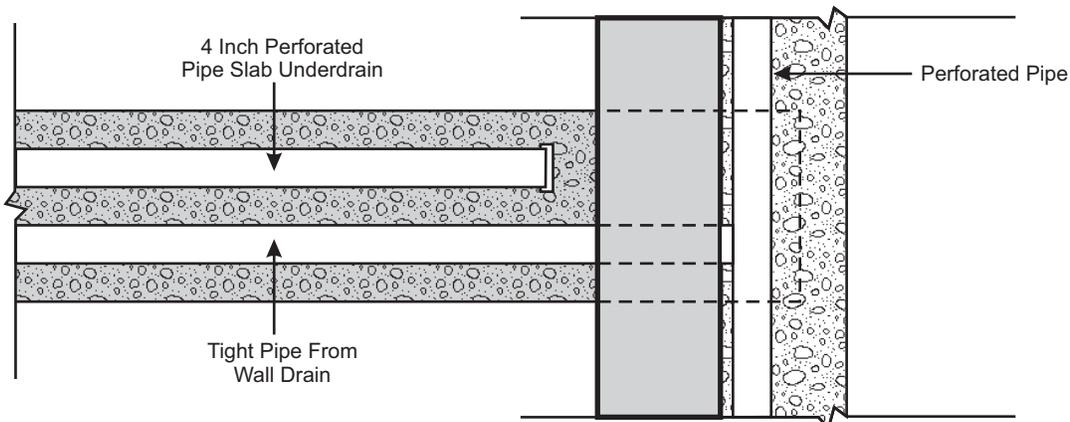
Profile View (Typical)

Plan View (Typical)
